# TECHNICAL SERVICE BULLETIN

| EC22-007 | NTB22-066 | July 29, 2022 |

## DTC P2DFD STORED IN THE ECM

**APPLIED VEHICLES:** 2022 Rogue (T33)

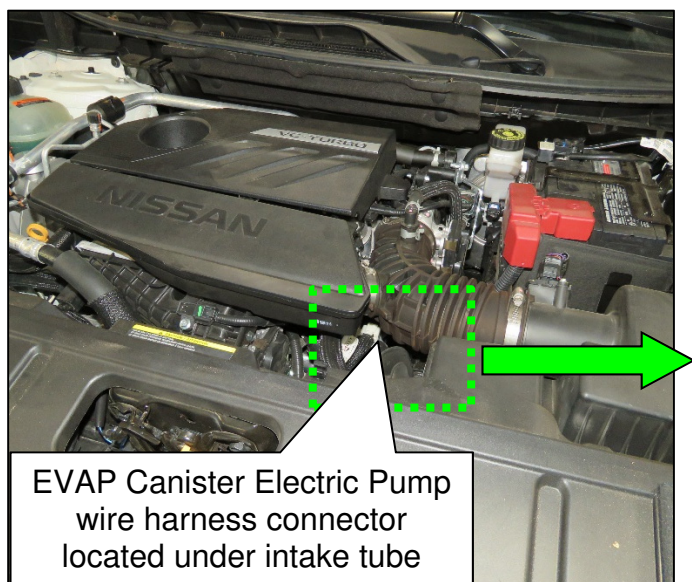
Figure 1

If you confirm DTC P2DFD (PURGE PUMP PERFORMANCE) is stored in the ECM,

1. Turn the ignition OFF.
2. Disconnect the EVAP Canister Electric Pump wire harness connector (Figure 2).
3. Re-connect the EVAP Canister Electric Pump wire harness connector and then verify the wire harness connector is fully seated, connected, and the wire harness connector lock tab is engaged (Figure 2).
