# TECHNICAL SERVICE BULLETIN

| AT21-003B | NTB21-023B | August 30, 2022 |

## DTC P0780 STORED IN THE TCM

**APPLIED VEHICLES:** 2021 Rogue (T33)

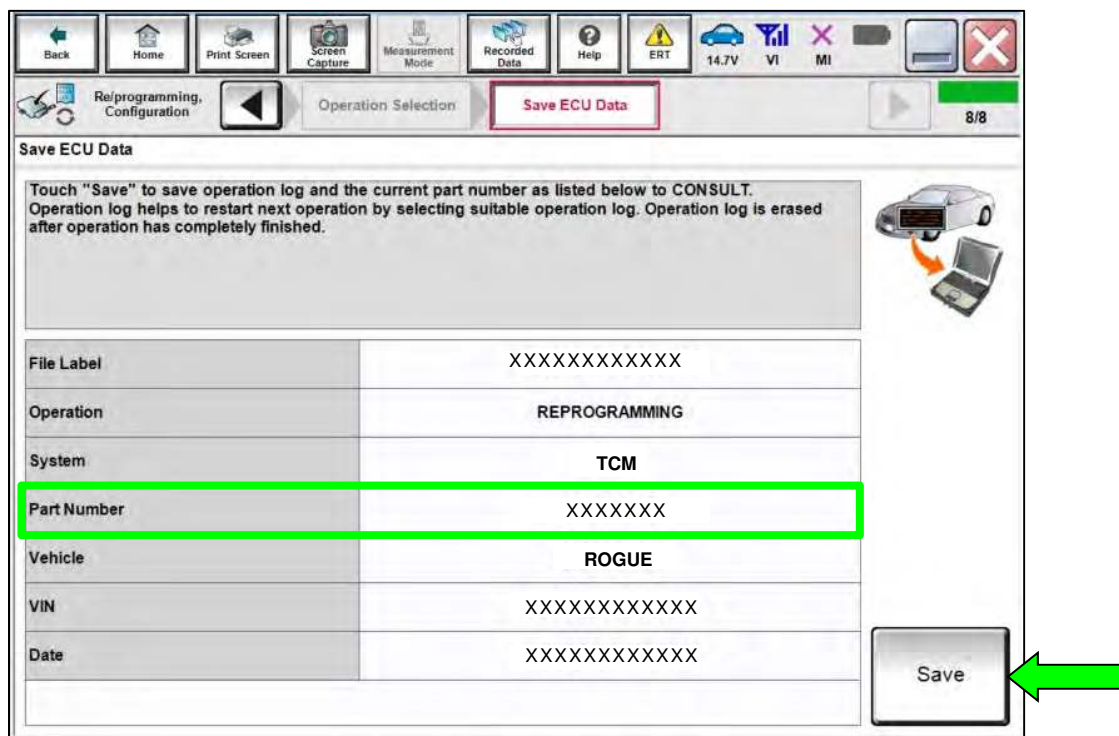
Figure 10

14. Find the TCM **Part Number** and write it on the repair order, and then select **Save**.

**NOTE:** This is the current Part Number (P/N).

15. Compare the Part Number you wrote down in step 14 on page 7 to the numbers in the **Current TCM Part Number** column in **Table A**, below.
  - If there is a match, continue to step 16 to reprogram the TCM.
  - If there is not a match, reprogramming is not needed. Skip to step 25 on page 13 to perform the **DTC Confirmation Procedure**.
