# Service Bulletin

Bulletin No.: 22-NA-113

**Subject:** Head Up Display (HUD) Blank, Non-Responsive to Brightness, Aim, or Page Controls, DTC U0158 Set

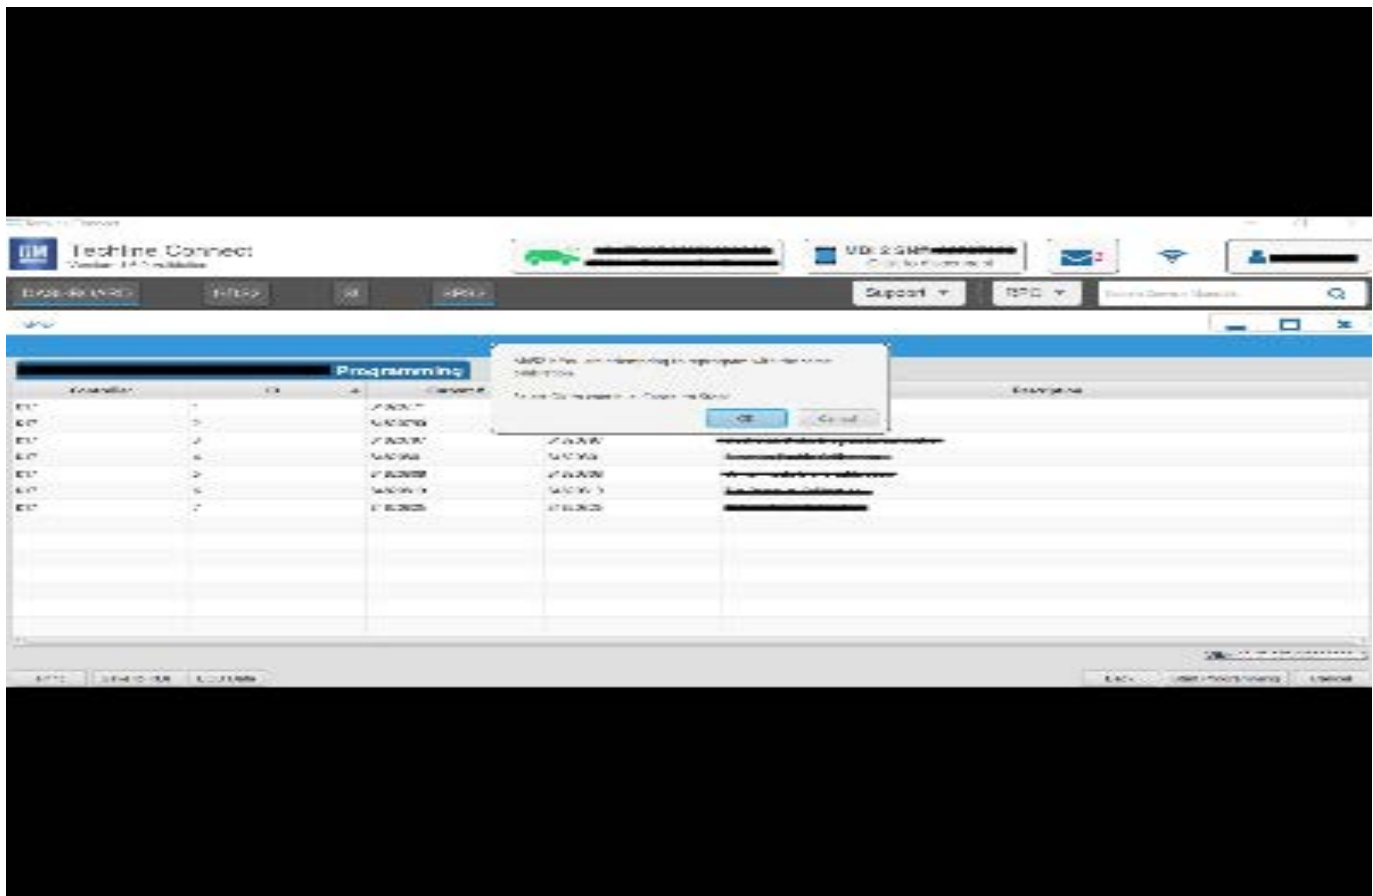
5644477

Important: Techline Connect screen shown above.

Important: If the same calibration/software warning is noted on the TLC or SPS Summary screen, select OK and follow screen instructions. After a successful programming event, the WCC is located in the Service Programming System dialogue box of the SPS
