June 2, 2023

## Accord CAN Gateway Errors DTC B2B05-92 and Code K201

Supersedes 23-045, dated May 23, 2023, to revise the information highlighted in **yellow**.

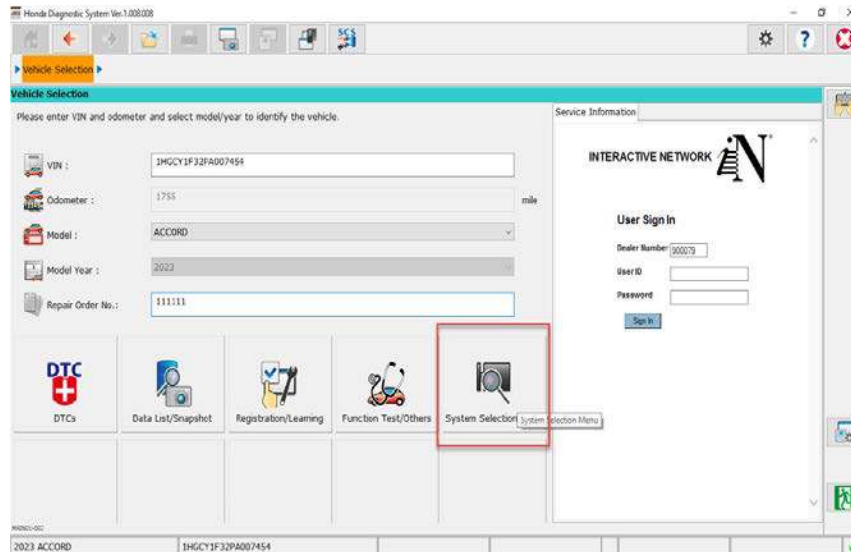
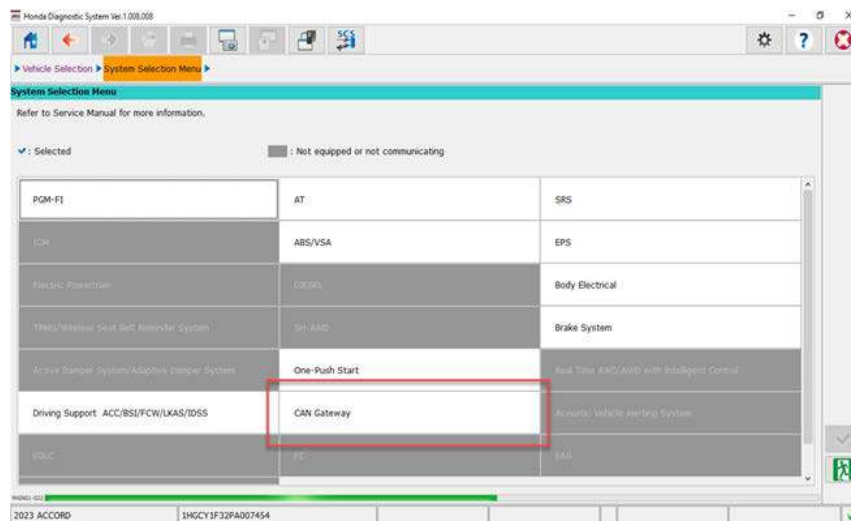
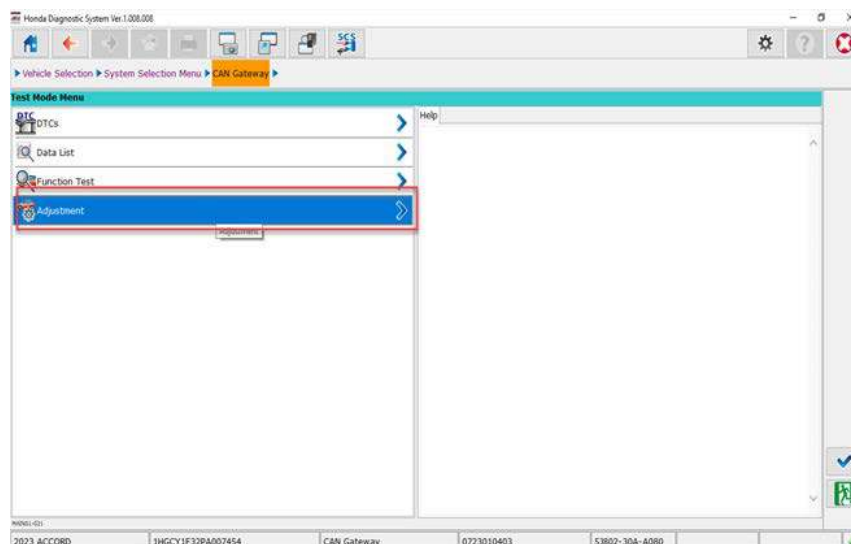
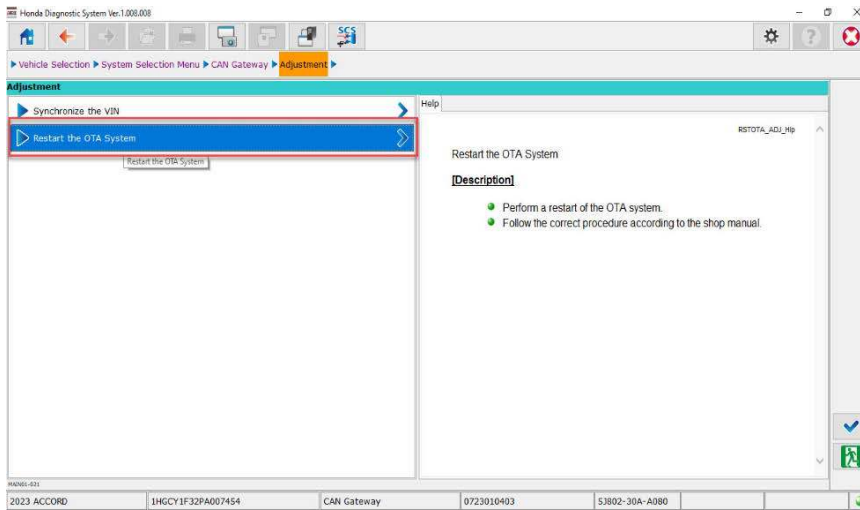
#### 4. Restart the OTA System.

NOTE: The pathway should be as follows: **System Selection Menu > CAN Gateway > Adjustment > Restart the OTA System**
