**HYUNDAI**  
**Technical Service Bulletin**

| GROUP<br><b>CAMPAIGN</b> | NUMBER<br><b>23-01-036H-1</b> |
| DATE<br><b>JUNE 2023</b> | MODEL(S)<br><b>ELANTRA (CN7A)<br/>SONATA (DN8A)<br/>SANTA FE (TMA)</b> |

**SUBJECT:** HECU MODULE DARK CURRENT MEASUREMENT AND REPLACEMENT (SERVICE CAMPAIGN 990)

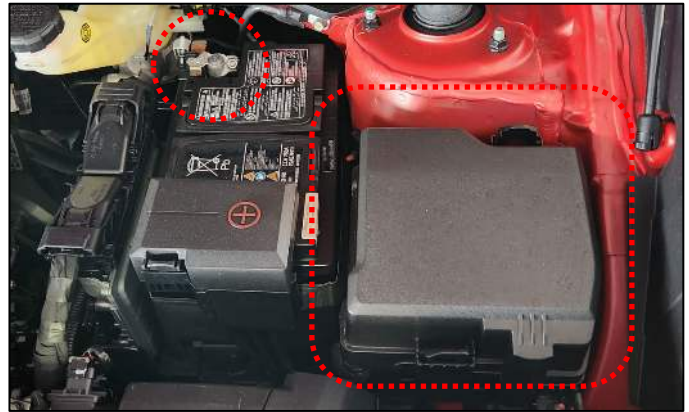
DN8A vehicles: The ABS fuse measurement location is under the right multi-fuse bar.

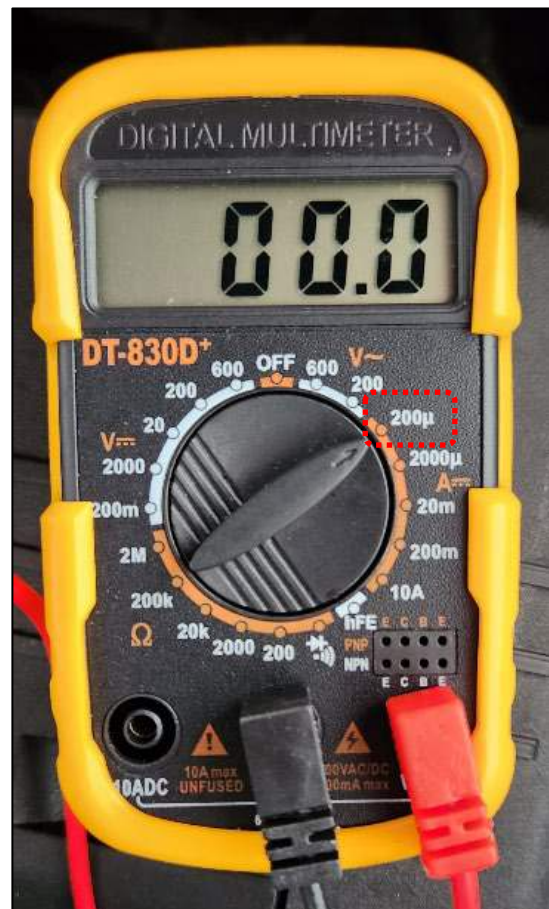
5. Set the multimeter to the 200  $\mu$ A setting.  
Connect the probe leads as shown – black in the center **COM** terminal, red on the right side **V $\Omega$ mA** terminal.
