## Technical product information

| <b>Topic</b> | New Continental GT and GTC - Window drop glass |
| <b>Transaction No.</b> | 2070497/2 |

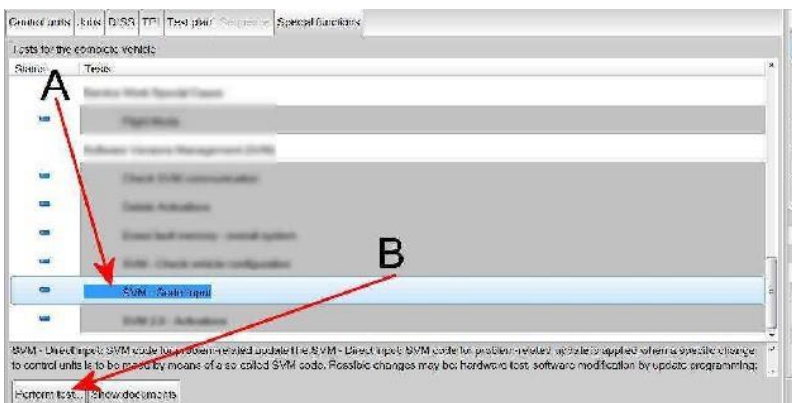
3) Referring to Figure 1 - Within the Special functions tab - Select SVM - Code Input (Point A)

- Select Perform test (Point B)

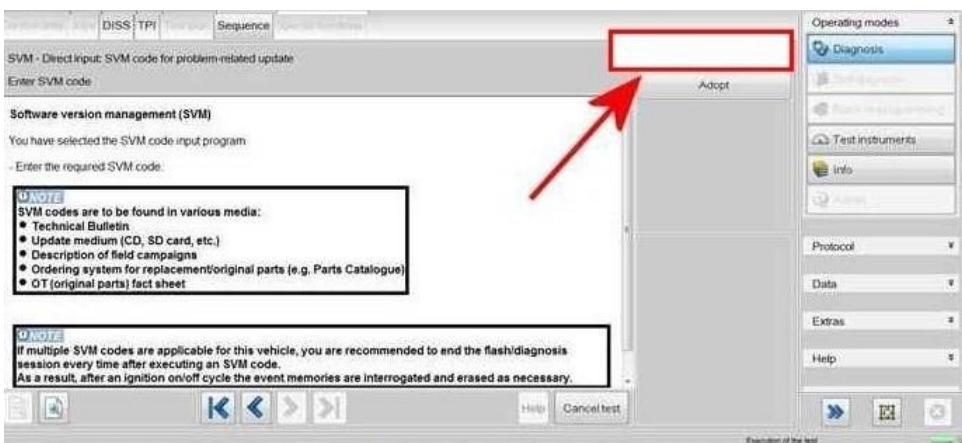
4) Referring to Figure 2 - Enter the SVM code 370FTM01

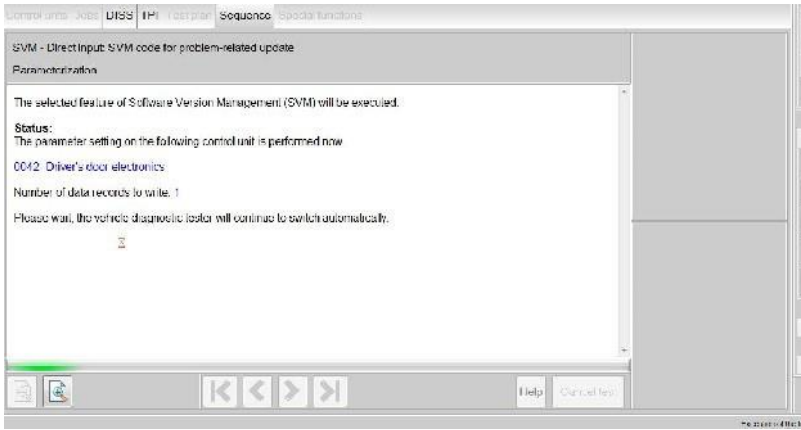
Figure 3

- When prompted enter your global user ID and password
  - Follow all on screen prompts to continue through the procedure, the identification data will be transferred
- 5) The Required control units will be automatically updated one by one, starting with 0042 – Door electronics Drivers side

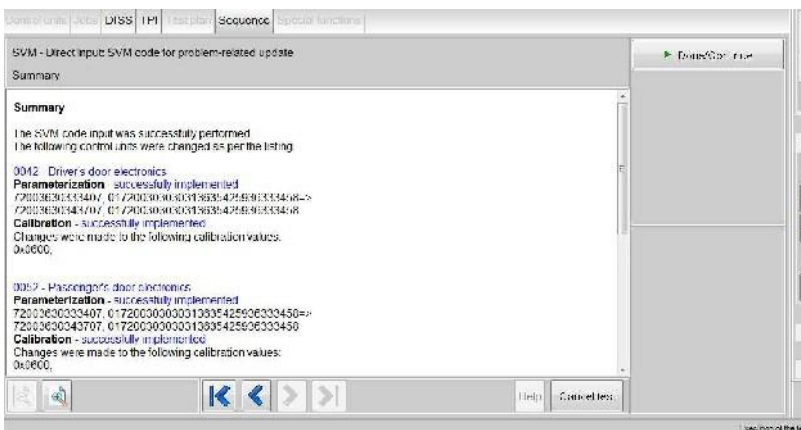
Figure 4

6) Once the update is complete the summary screen will be shown in Figure 4, this confirms completion of the required updates

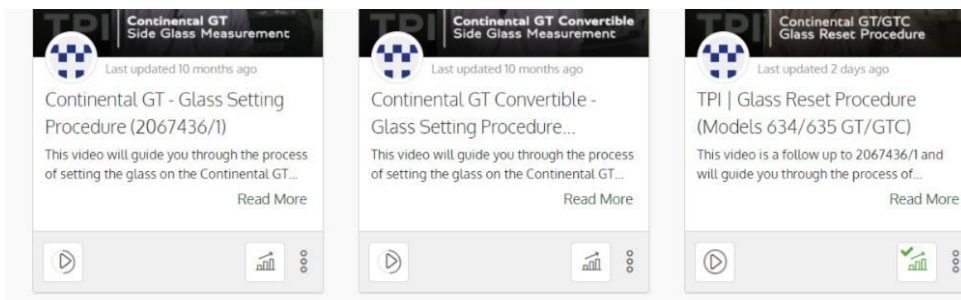
- The operative must review the (x3) videos which are available on the Digital Learning HUB (see example shown in Figure 11 of all videos which must be reviewed)
