| | Voluntary Emissions Service Campaign | 2023MY Sportage (NQ5a) |
| | SC268 | July 2023 |
| SUBJECT: FUEL FILLER NECK VENT COLLAR INSPECTION & REPLACEMENT (SC268) | | |

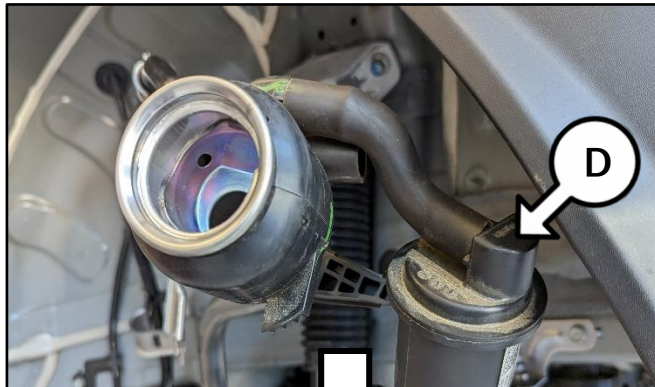
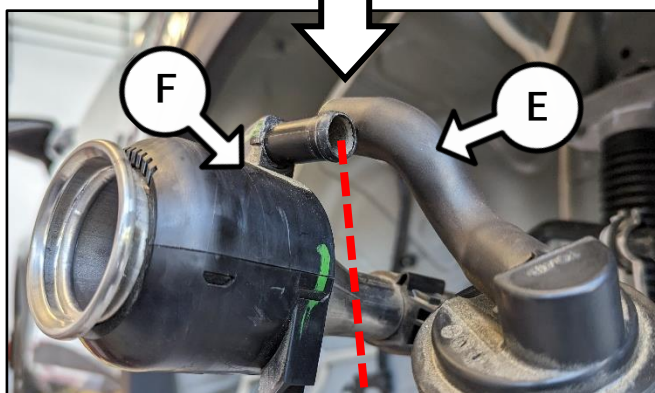
6. Detach the fuel tank filter (D) vent hose (E) from the vent collar (F).

Do **NOT** twist or rotate the vent collar when removing vent hose (E). Doing so may damage the vent collar.

7. Using a flashlight, inspect the vent collar (F) vent port and confirm the following conditions:

- Vent collar port is not blocked (OK), then reinstall all removed parts in the reverse order of removal to complete this service action.
- Vent collar port is partially blocked (NG), then proceed the 'Repair Procedure' on page 4 to replace the vent collar.
