## Technical Service Bulletin

| <b>CAMPAIGN</b> | <b>23-01-060H</b> |
| <b>JULY 2023</b> | <b>IONIQ 5 (NE1)</b><br><b>IONIQ 6 (CE1)</b> |

**SUBJECT:** DTC P1A9096 CHECK FOR ICCU & FUSE REPLACEMENT  
AND ICCU SOFTWARE UPDATE (SERVICE CAMPAIGN 997)

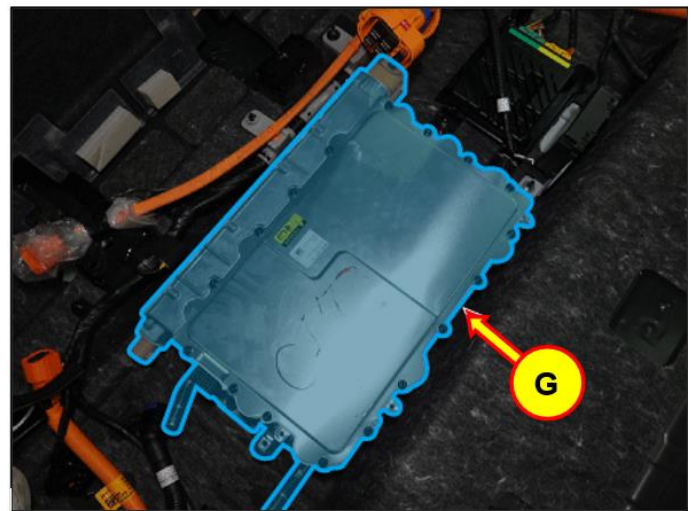
- C10. After removing the mounting bolts, remove the ICCU (G).

- C10. Install the replacement ICCU and take STUI photo for upload once installed.

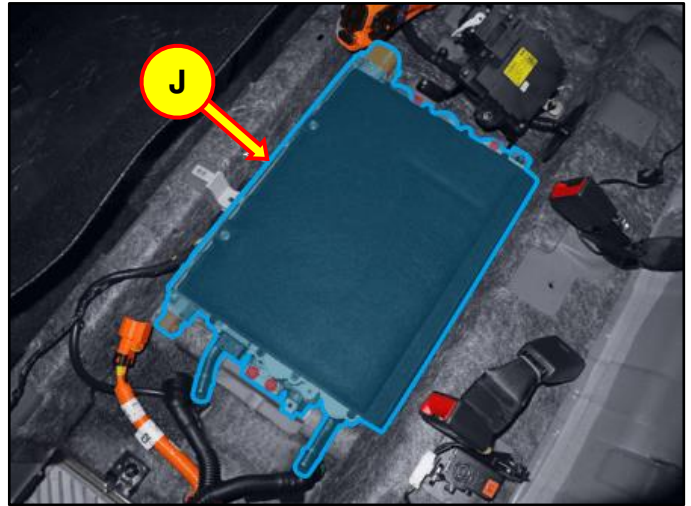
D8. After removing the bolt, remove the ICCU (J).

D9. Install the replacement ICCU and take STUI photo for upload once installed.

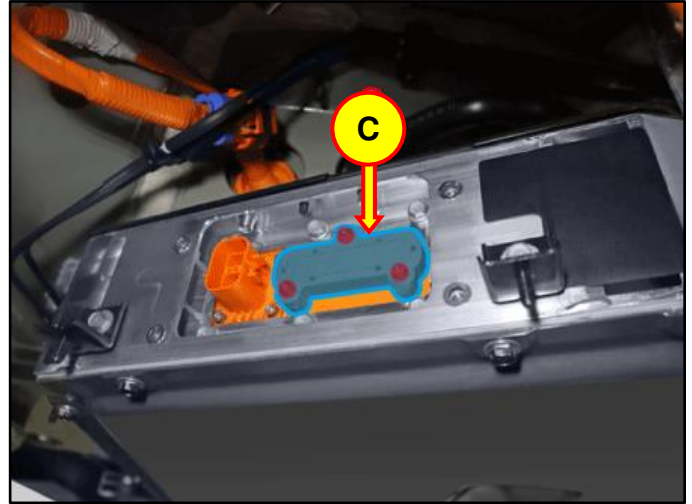
E5. Remove the ICCU fuse cover (C).

E6. Using a commonly available multimeter. Set at the ohmmeter measuring mode and inspect the fuse condition by checking the fuse's resistance value:

- **Fuse is Good:** Less than 1.0 ohm.

**DO NOT REPLACE THE FUSE.**  
**Do not follow the remaining steps to replace the fuse.**

**ONLY REPLACE THE FUSE IF FOUND TO BE BAD (BLOWN/OPEN).**
