# Technical Service Bulletin

## 01 MIL on, DTC P040100 is stored in the ECM - TDI

01 23 68 2064398/3 August 11, 2023. Supersedes Technical Service Bulletin Group 01 number 23-63 dated July 25, 2023 for reasons listed below.

| Model(s) | Year | VIN Range | Vehicle-Specific Equipment |
|---|---|---|---|
| A3 TDI | 2010 – 2013 | All | Not Applicable |

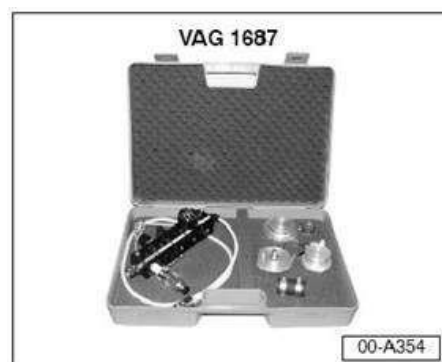
1. The charge air pressure system can be checked using the VAG 1687. Charge air system tester along with the VAG1687/10 adapter as follows:

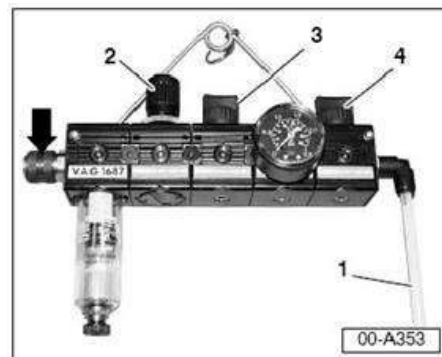
2. **Special tool VAG 1687 Charge air system tester, preliminary set-up**
  - Back off pressure regulator knob -2- of VAG 1687 fully to protect gauge when shop air supply is applied to the assembly.
  - Close valve -3- before gauge.
  - Close valve -4- after gauge.
  - Shop air supply line will later be attached to the inlet of VAG 1687.
  - Remove the “female” fitting from the tester (arrow) and install an appropriate “male” air fitting that will connect to your shop air supply line (See Note below).

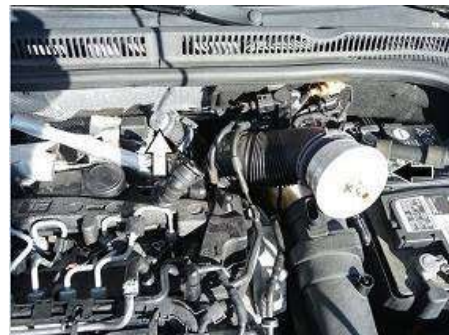
## 3. Special tool VAG 1687/10 pressure adapter, installing.

- Separate intake hose from the Mass Airflow Sensor assembly (MAF).
- Insert VAG 1687/10 pressure adapter in intake hose -black arrow- using existing clamp (as shown).
- Remove crankcase ventilation valve or tube from intake hose at -white arrow-.
- Plug hose with appropriate metal plug and hose clamps supplied with VAG 1687 special tool kit at -white arrow-.

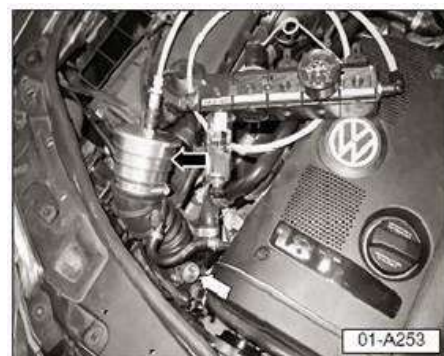
## Special tool KLI9210 (EVAP system leak detector)

- Install optional fitting KLI 9210/50 on hose of special tool KLI9210.
- Connect KLI9210 to VAG 1687/1 adapter (KLI 9210 is shown attached to VAG1687/1 at arrow on 1.8L Turbo).

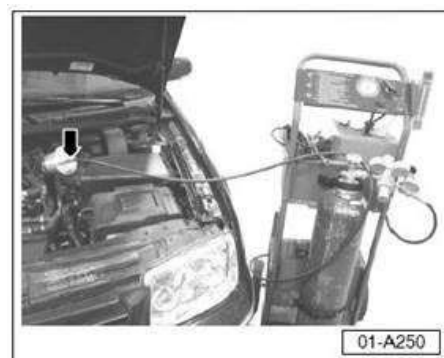
## Special tool KLI9210 (EVAP system leak detector)

- Install optional fitting KLI 9210/50 on hose of special tool KLI9210.
- Connect KLI9210 to VAG 1687/1 adapter (KLI 9210 is shown attached to VAG1687/1 at the arrow on 1.8L Turbo).

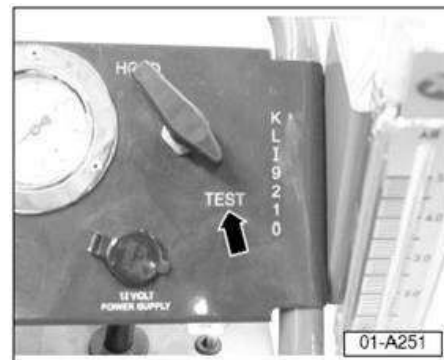
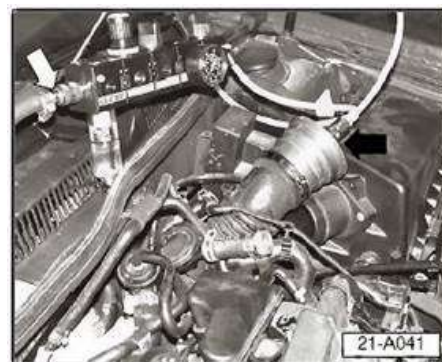
## Special tool VAG 1687 connecting to pressure adapter 1687/10

- VAG 1687 is shown connected to VAG 1687/10 (black arrow).
- Shop air supply connected to VAG 1687 at (white arrow).
- Perform pressure test.

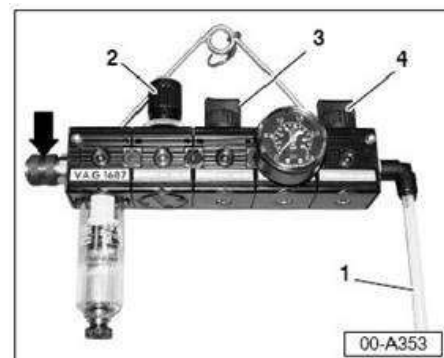
## Performing the Pressure Test:

- With outlet the hose -1- of VAG 1687 connected to the air pressure adapter.
- Attach the shop air supply line to the previously installed male fitting.

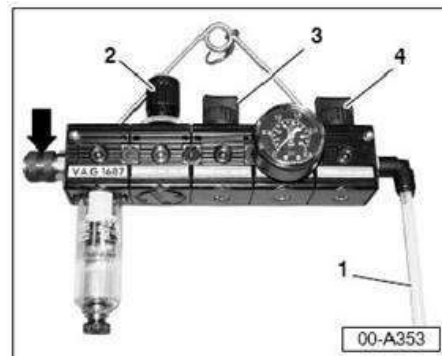
- Slowly open outlet valve -4- (after gauge) to test hose connections.
- Observe the pressure gauge for a drop in pressure.
