# Technical Service Bulletin

## 87 Air conditioning does not cool - P053000, P251500 stored in C5

87 23 50 2068460/4 August 10, 2023. Supersedes Technical Service Bulletin Group 87 number 23-40 dated April 10, 2023, for reasons listed below.

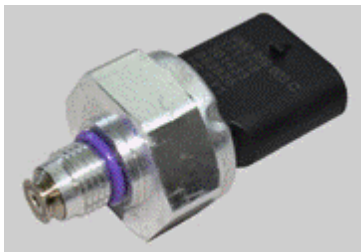
A failure of the sensor electronics causes a loss of pressure evaluation. The sensor with base part number 4M0959603 and a build date before the date Calendar Week 31, 2021 is at issue (G395 / G827).

2. Inspect the markings on the sensor to determine if the sensor has been previously replaced with an improved sensor produced after Calendar Week 31, 2021. Figure 1 shows the locations of the markings and their interpretation. In this example, while the sensor is an 'E' index sensor, contains a green dot on the connector housing and a laser marking on the aluminum housing the build date of the sensor is *before* Calendar Week 31, 2021, and would require replacement.

3. A sensor with index 'E', produced after Calendar Week 31, 2021, has a laser marking on the aluminum housing and may or may not contain a green dot on the connector housing is of the improved type and need not be replaced.

1. Should the vehicle present with the symptom profile described in this TSB inspect and/or replace all of the pressure sensors in the refrigerant circuit that are of the base part number 4M0959603 and have a build date before Calendar Week 31, 2021. Each model for which this TSB appears will have between 1 and 3 of this type of sensor installed at various positions in the refrigerant circuit, either on the low or high pressure sides of the circuit (G395 / G827).
