| <b>Topic</b> | New Continental GT and GTC - Window drop glass operation |
| <b>Transaction No.</b> | 2070497/3 |

Retailer glass reset procedure for GT/GTC

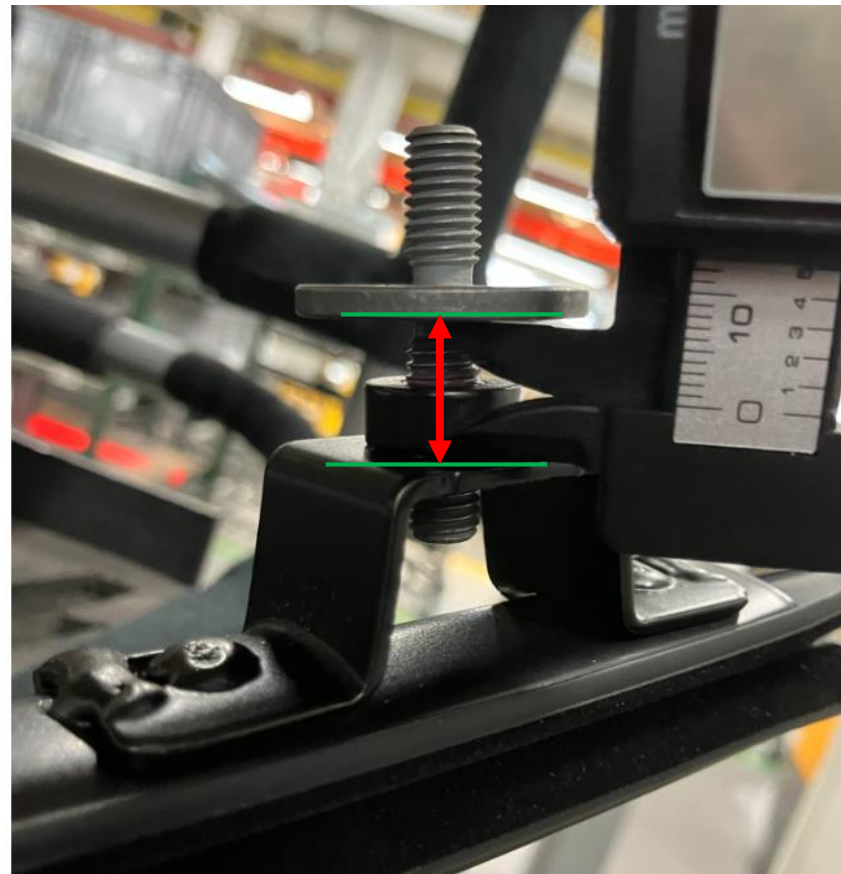
Measurement between bottom of mounting washer and division bar frame, is 12.5mm.

To reset this adjuster without removing the quarter glass, loosen the lock nut, screw the adjuster all the way in clockwise until it bottoms out on the frame, then unscrew anti clockwise 4 complete turns then set height and profile to ELSA specification before moving on to the next step.

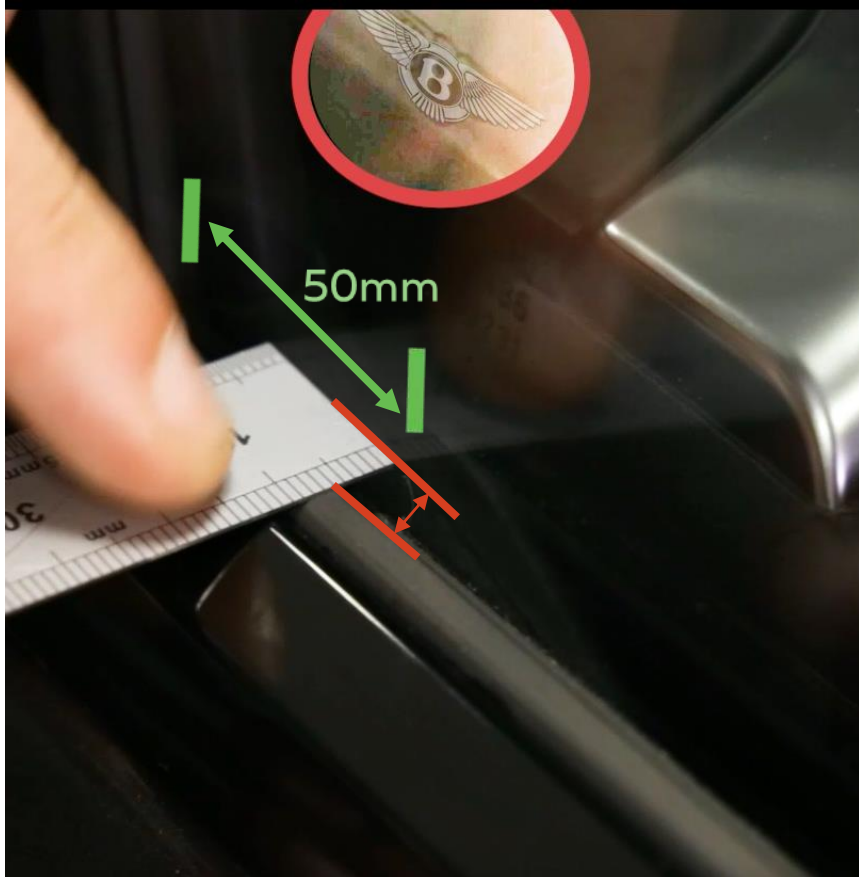
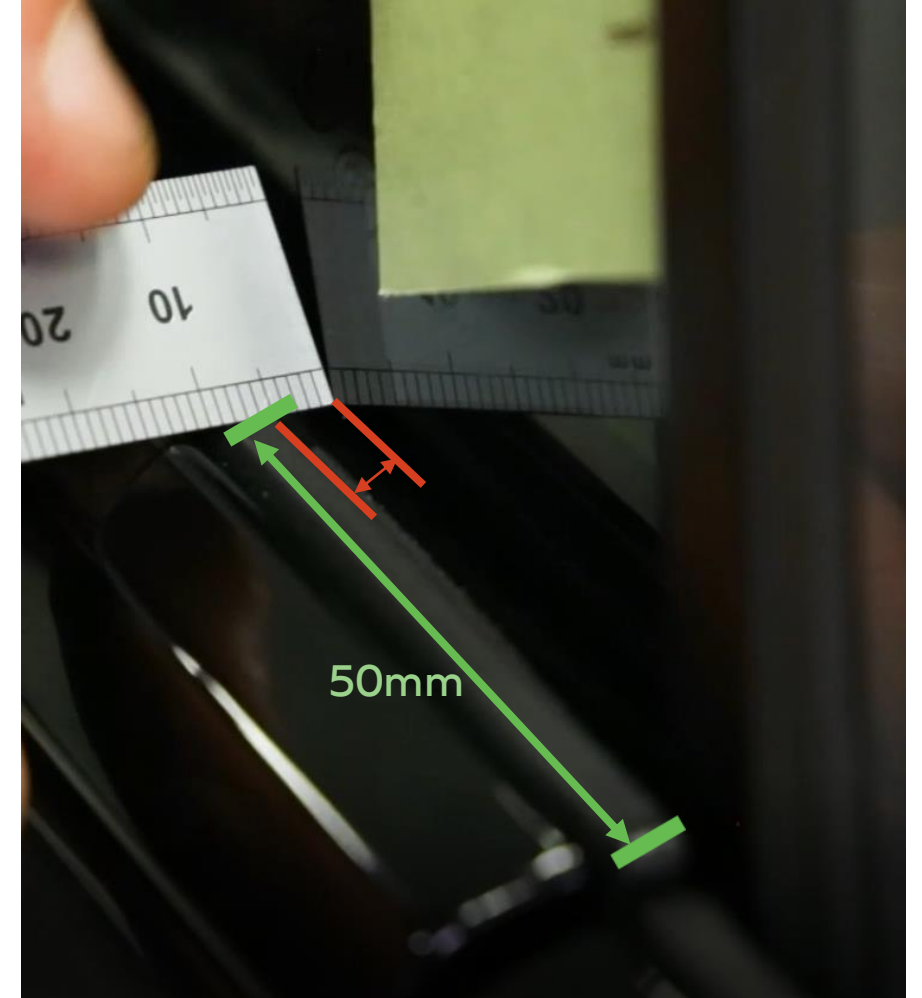
2mm at rear edge would have been set to achieve specified flush/2mm underflush profile condition between front and rear glasses, the rear quarter glass mirrors this taper condition. This potentially increases the risk of false anti trap as rear window/seal does not engage with front window at the correct angle. Suggested to set to specification on problem vehicles as per next slide. If both windows are set between 4-6mm then the flush/2mm underflush profile can be easily achieved.

Set waist rail gapping to between 4-6mm as mentioned in Glass setting guide videos on E-Academy and also check for parallelism along front and rear windows to door/quarter. 50mm from edge of Waistrail seal, roughly underneath the Bentley wings.
