| <b>Topic</b> | New Continental GT and GTC - Window drop glass operation |
| <b>Transaction No.</b> | 2070497/4 |

Retailer glass reset procedure for GT/GTC

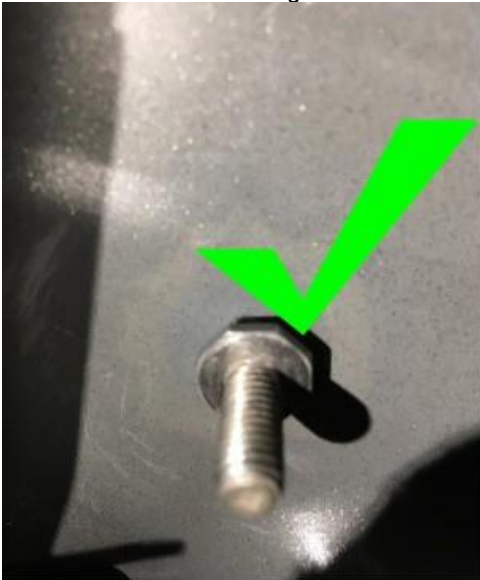
- Remove any dirt/paint/debris from the earth points using suitable abrasives/wire brush ensuring no damage is caused to the earth stud threads as shown in Figure 8

- Secure the earth point fixings (9 Nm)
