Subject: N232427260 - Customer Satisfaction Program  
Diesel Exhaust Fluid Control Module

Models: 2021 Chevrolet 6500XD Low Cab Forward (LCF)

# Customer Satisfaction Program

## N232427260 Diesel Exhaust Fluid Control Module

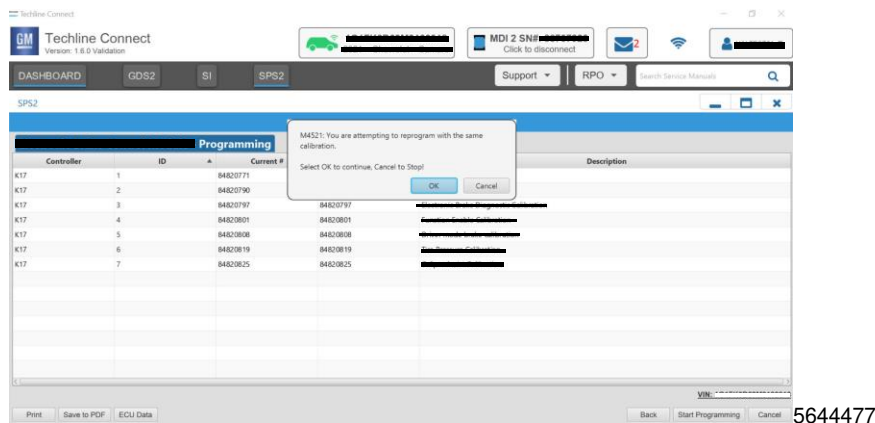
**Important:** Techline Connect screens shown above.

**Important:** If the same calibration/software warning is noted on the TLC Summary screen, select OK and follow screen instructions. After a successful programming event, the WCC is located in the Service Programming System dialogue box of the SPS Summary screen. No further action is required. Refer to the Warranty section of the bulletin.
