**Bulletin #: 2104.6**

### Y1A Taycan

### On Board Charger (OBC) Fault P31D200 "Charging Socket – Overtemperature"

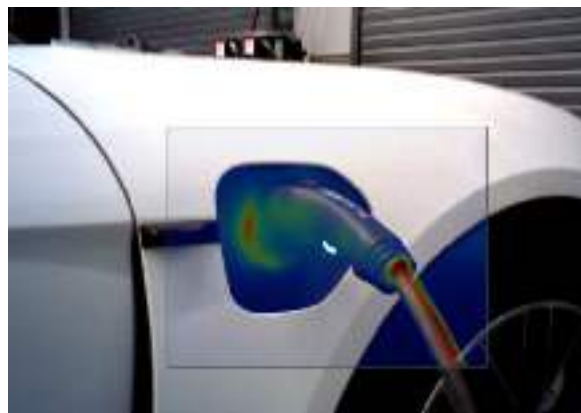
Figure 2

Vehicle cables which have been severely or repeatedly overheated may lead to a stopped charging session without the OBC storing Fault Code P31D200. If no damage is visually apparent, and the fault code cannot be duplicated through testing, then it will be necessary to verify the problem follows the vehicle cable itself. Check if high temperatures at the vehicle cable charge handle and/or a stopped charging session follows the vehicle cable by charging another vehicle using the same hardware.

New vehicle cables are available with thicker wiring to prevent repeat occurrence of this condition.

Customers with a Mobile Charger Connect (PMCC) who experience the condition described above shall receive a new, thicker vehicle cable in exchange for the failed vehicle cable.
