| <b>Topic</b> | New Continental GT and GTC - Window drop glass operation |
| <b>Transaction No.</b> | 2070497/6 |

- Incorrect operation/function of the front and/or rear window drop glass
- Front and/or rear drop glass fails to open/close or attempts to close and re-opens once contact has been made between the glass and applicable seal
- DTC for window regulator motor no basic setting B148754 evident within any of the 4 window control modules (diagnostic address 42, 52, BB and BC) for loss of basic settings

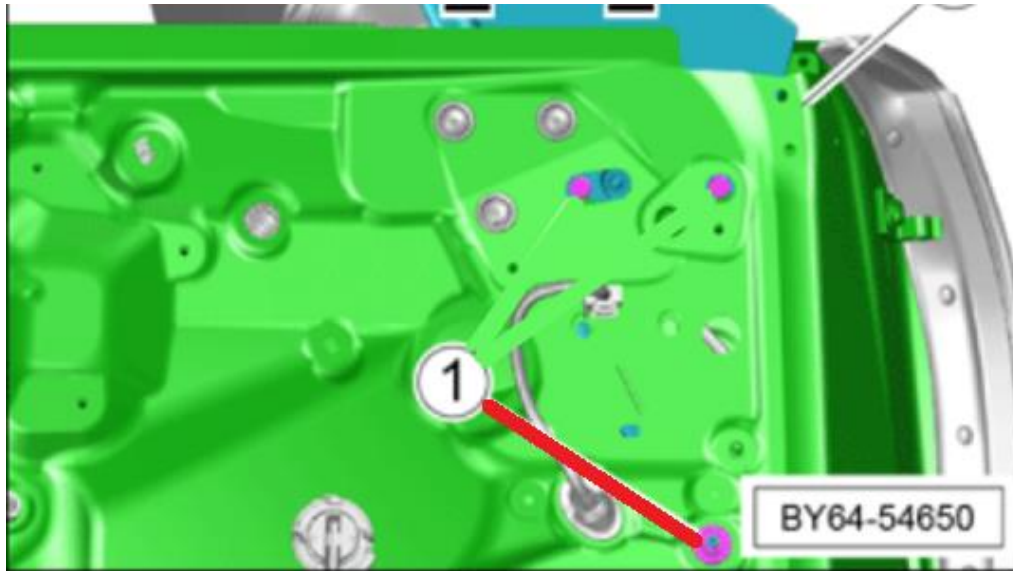
Measurement between bottom of mounting washer and division bar frame, is 12.5mm.

To reset this adjuster without removing the quarter glass, loosen the lock nut, screw the adjuster all the way in clockwise until it bottoms out on the frame, then unscrew anti clockwise 4 complete turns then set height and profile to ELSA specification before moving on to the next step.

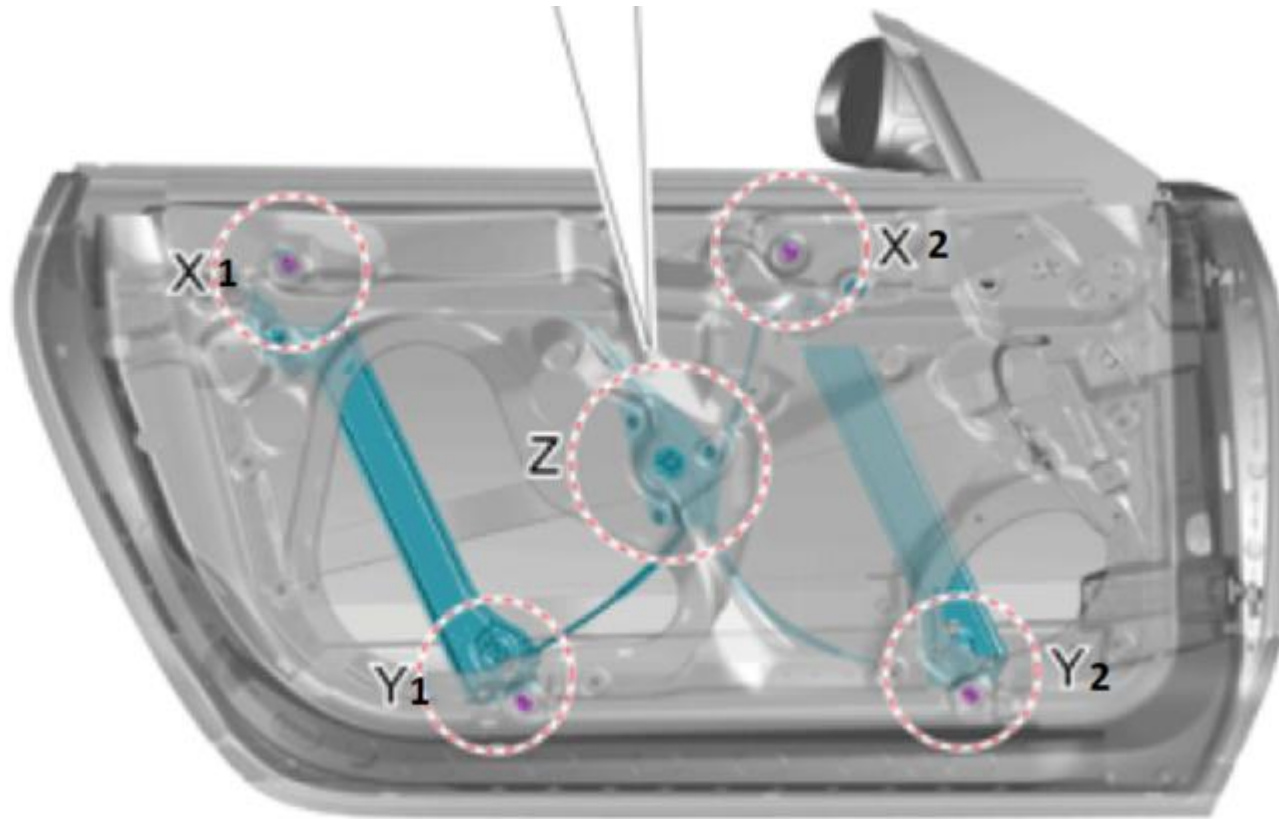
**Regulator adjusters X1 X2**

Measure from top of mounting washer to frame
