## Technical product information

| <b>Topic</b> | Rotating display/screen - Fault diagnosis - Mechanical malfunction DTC B140107 is evident within 005F |
| <b>Brand</b> | Bentley |
| <b>Transaction No.</b> | 2067955/4 |

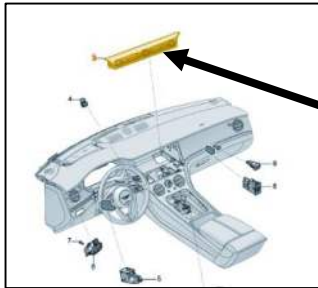
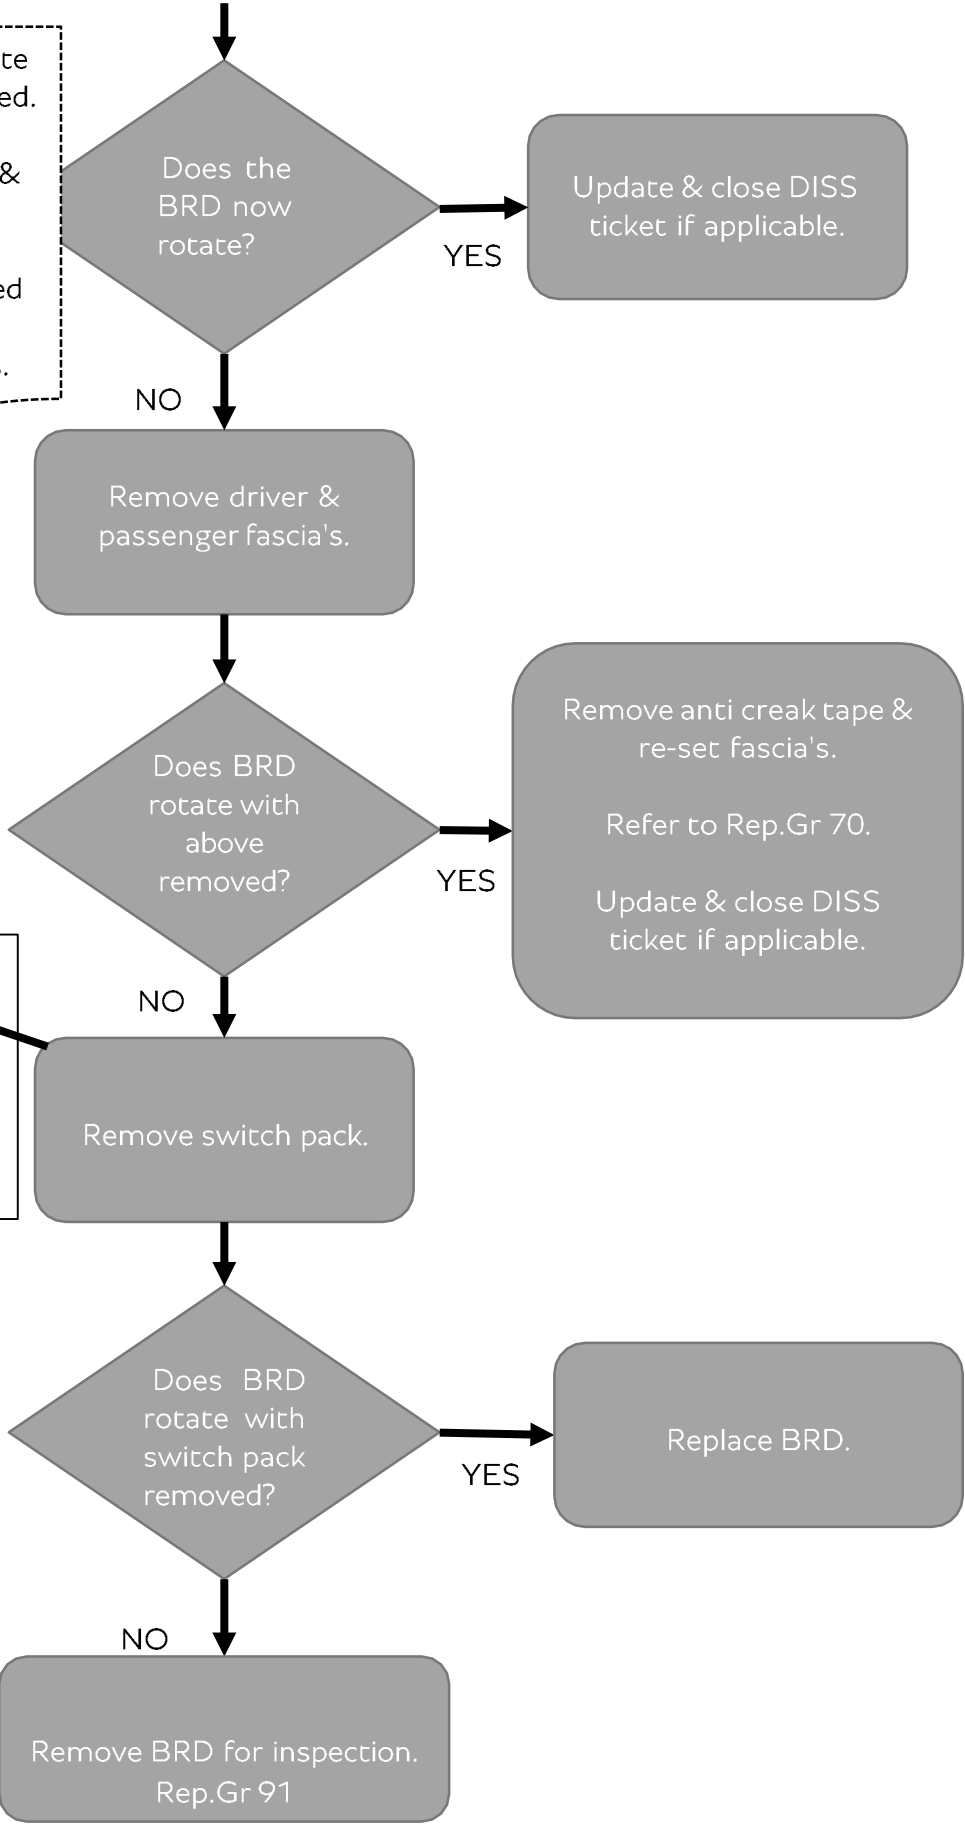
Note: for the BRD to rotate it must be correctly balanced.

For example screen, plain & gauge fascia's fitted.

x1 Balance weight removed for E revision screen & chrome pinstripe fascia's.
