2019MY  
Optima (JFa),  
Sorento (UMa), and  
Sportage (QL)

PI1805Y/Z

January 2024

### ENGINE REPLACEMENT INSTRUCTIONS FOR DTC P1326 (PI1805Y/Z)

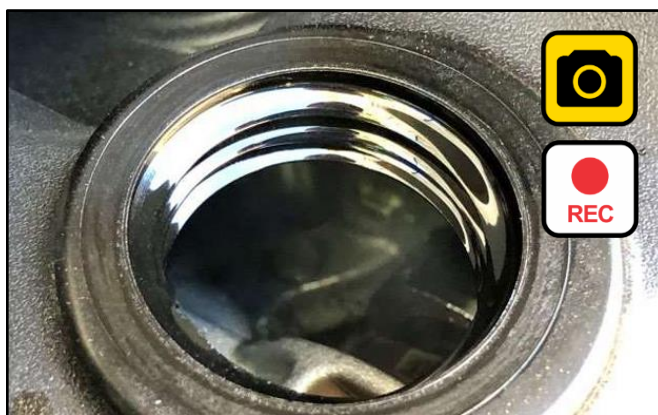
**If oil lacquering, oil sludge or oil varnish is present, then the engine is therefore suspect to maintenance neglect. Review of the vehicle's maintenance history is required.**
