# Service Bulletin

Bulletin No.: 22-NA-007

**Subject:** Poor Engine Performance in Extremely Cold Weather Conditions for LE2 Engines, Charge Air Cooler (CAC) Icing - Malfunction Indicator Lamp (MIL) Illuminated, DTC P0299, P0234, P0236, P2227, P00C7 Set

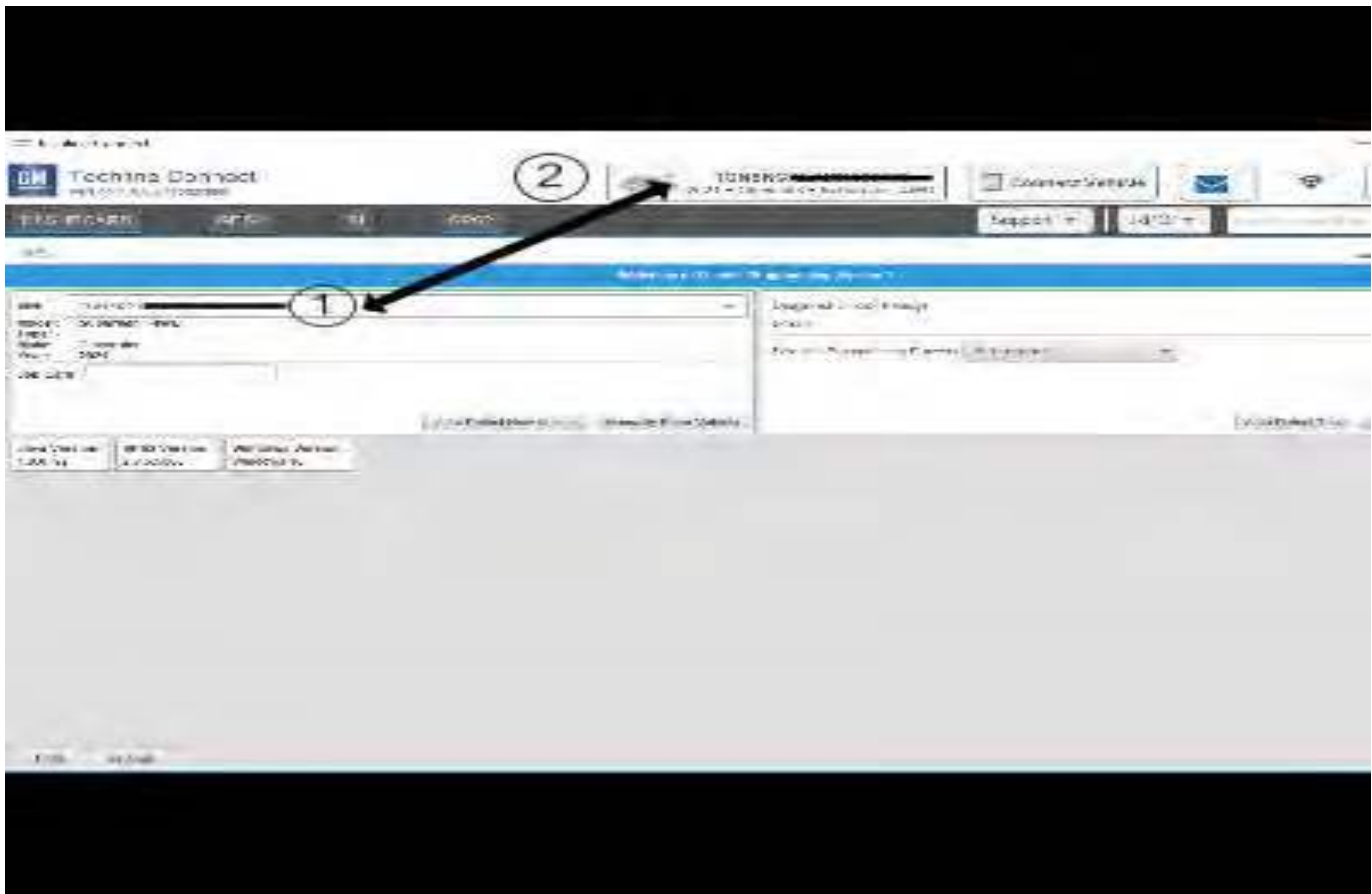
5743643

Caution: Be sure the VIN selected in the drop down menu (1) is the same as the vehicle connected (2) before beginning programming.

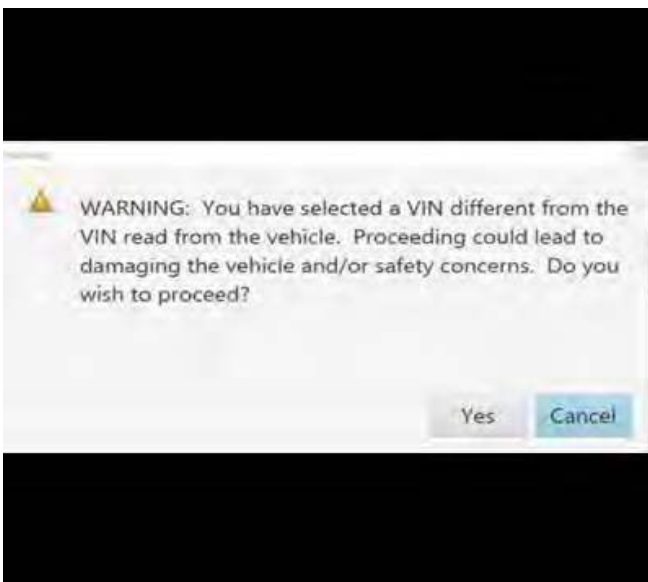
5877000

Important: If the vehicle VIN DOES NOT match, the message below will be shown.

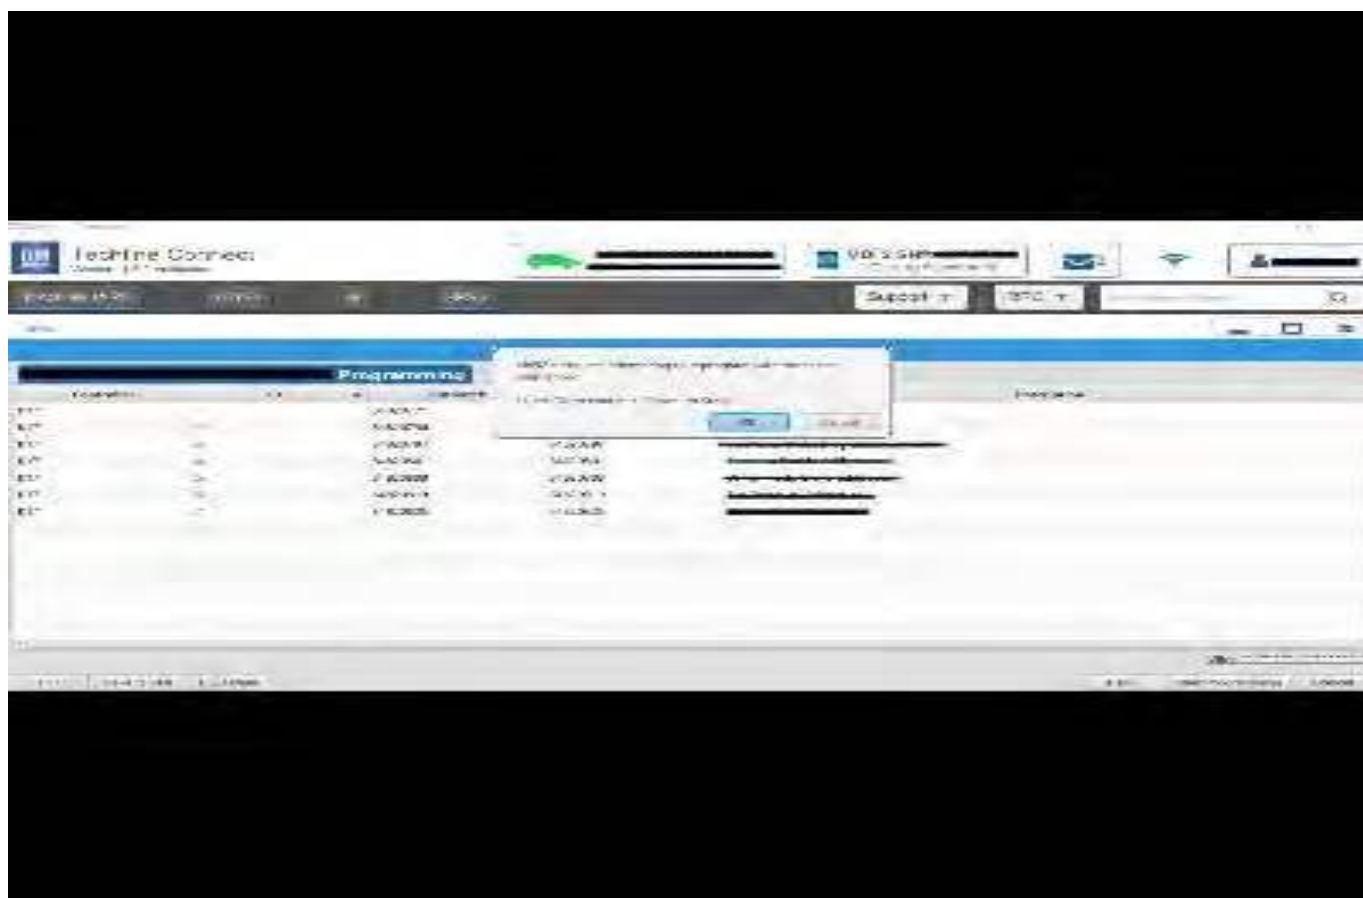
5644477

Important: Techline Connect screen shown above.

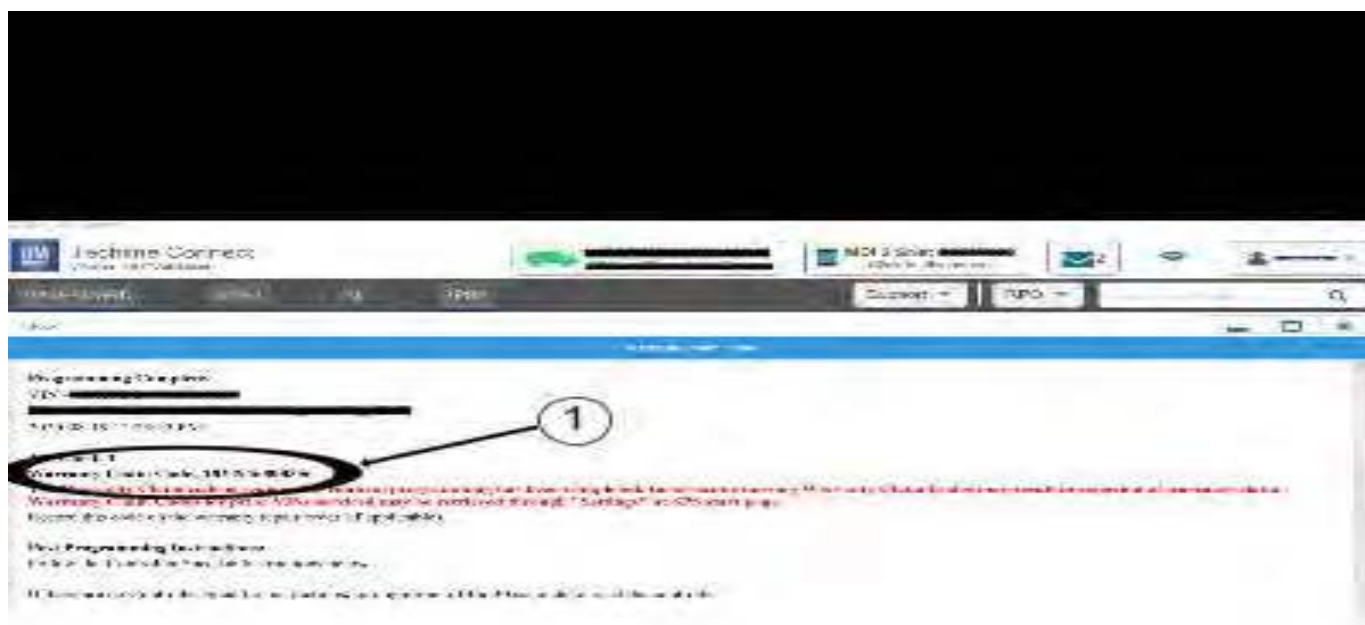
Note: The screenshot above is an example of module programming and may not be indicative of the specific module that is being programmed. Module selection and VIN information have been blacked out.

Important: To avoid warranty transaction rejections, you **MUST** record the warranty claim code provided on the Warranty Claim Code (WCC) screen shown above on the job card. Refer to callout 1 above for the location of the WCC on the screen.

1. Reprogram the ECM. Refer to K20 Engine Control Module: Programming and Setup in SI.
