NUMBER  
PI1802Y/Z (Rev 7, 03/22/2024)

### ENGINE REPLACEMENT INSTRUCTIONS FOR DTC P1326 (PI1802Y/Z)

This bulletin provides information related to the Technical Service Bulletin previously published [PI1802](#) titled "Knock Sensor Detection System - ECU Logic Improvement" equipped w/THETA II engine. Specifically, this bulletin provides instructions on which procedures to follow if, after installation of the KSDS, any one of the subject vehicles below returns to the dealer with Diagnostic Trouble Code (DTC) P1326 (Knock Signal Range/Performance).

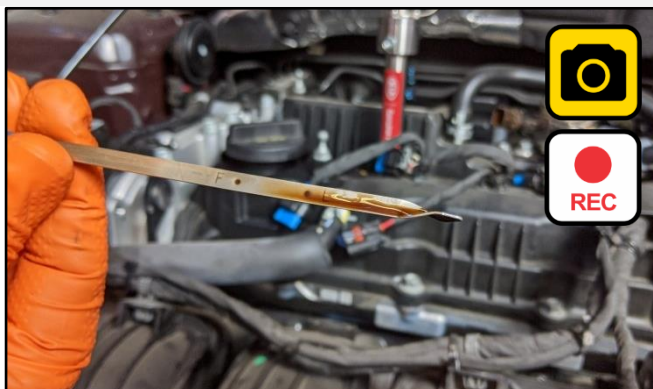
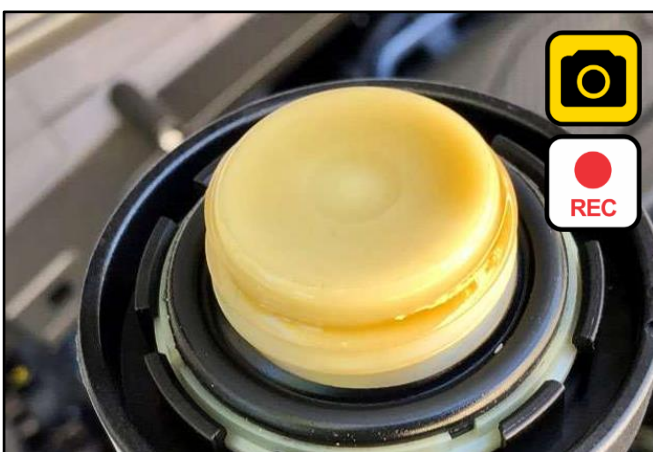
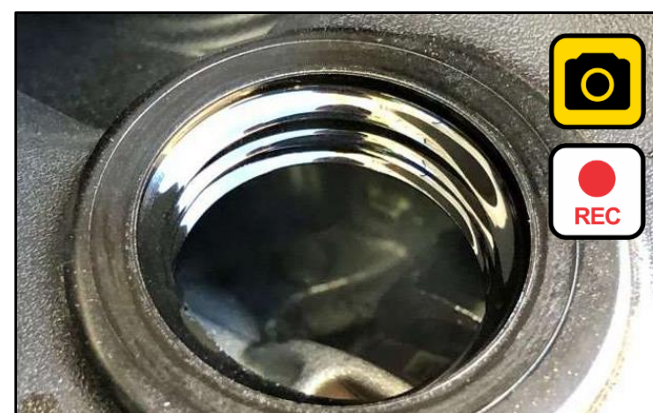
1. Start video showing vehicle and move in towards the dash VIN tag.
2. Measure and record oil dip stick level.
3. Note oil dip stick reading on the RO.
4. Take a picture of the oil reading on dipstick.
5. Inspect the inner/bottom of the oil cap and inside oil filler opening.
6. Take a picture of both, the bottom of the oil cap and oil filler opening.

**Record/Note findings:** No oil, oil sludge, varnish, burnt oil smell condition(s) found.

If NO oil is registered on the dipstick, or oil lacquering, oil sludge and/or oil varnish is present (NG), then the engine is therefore suspect to maintenance neglect. Review of the vehicle's maintenance history is required.

If suspect, proceed to the 'Oil Level Measurement' instructions below and submit with the Techline case.
