## SERVICE BULLETIN

**APPLICABILITY:** 2014-18MY Forester

**NUMBER:** 17-19-24

**SUBJECT:** DTC B1760 Occupant Detection Sensor Mat /  
Diagnosis & Repair Procedures

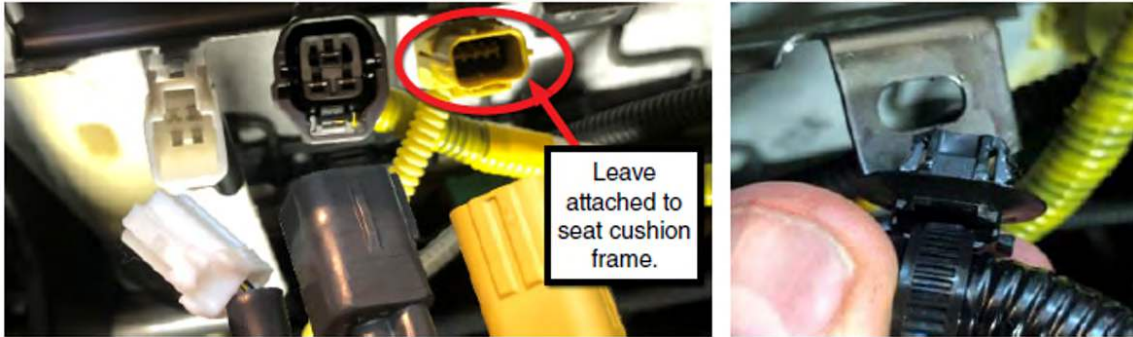
**STEP 1:** **CAREFULLY** disconnect the three (3) seat harness connectors and the harness retaining clip. Leave the yellow Airbag harness connector attached to the seat cushion frame.

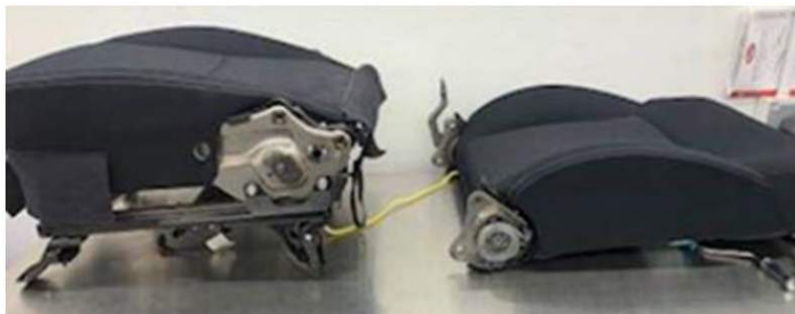
**STEP 4:** Disconnect the seat heater harness connector. Remove the bolts (2 inner and 2 outer), then **CAREFULLY** separate the backrest assembly and set it aside as shown in the photo below.

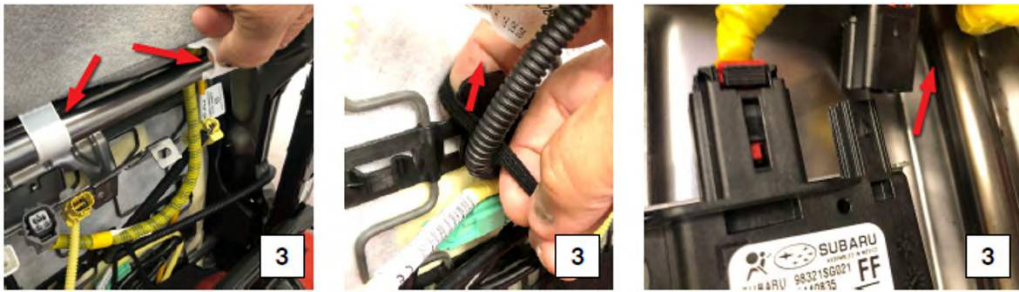
**STEP 5:** Unclip the two retaining loop / clips from the seat cushion front frame, unhook the elastic loop with a finger and unplug the ODS mat harness from the ODS module as shown in the sequence below.

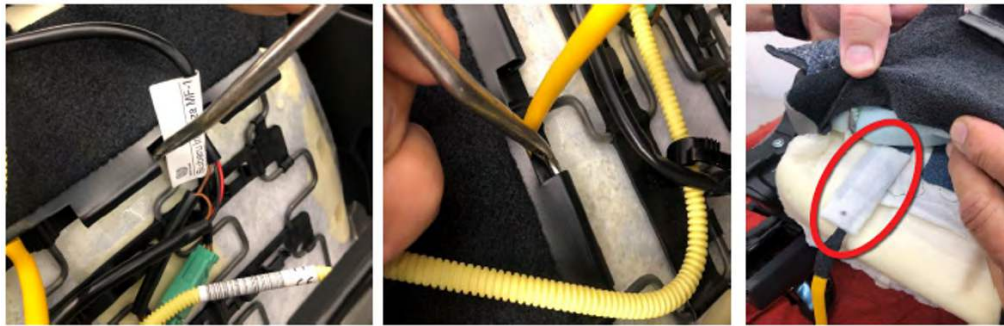
**STEP 6:** From the rear of the cushion (a cotter pin extractor works well), **CAREFULLY** release the plastic seat cover trim retainers as shown below and pull the back of the cover up as needed to access the harness to ODS sensor mat connection point (tail) circled below. The tail is covered in a self-adhesive fabric padding.

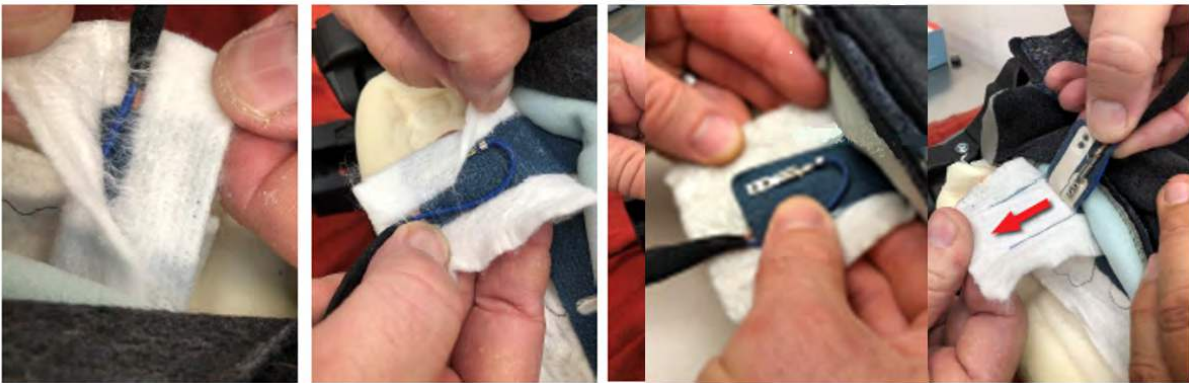
**STEP 7:** **CAREFULLY** peel the padding back to expose the tail and connections. Be advised, the adhesive used has a very strong grip. Hold the blue wire and **CAREFULLY** peel the padding in a direction parallel to the tail and discard. A new piece of self-adhesive fabric padding is included in the new replacement harness kit.

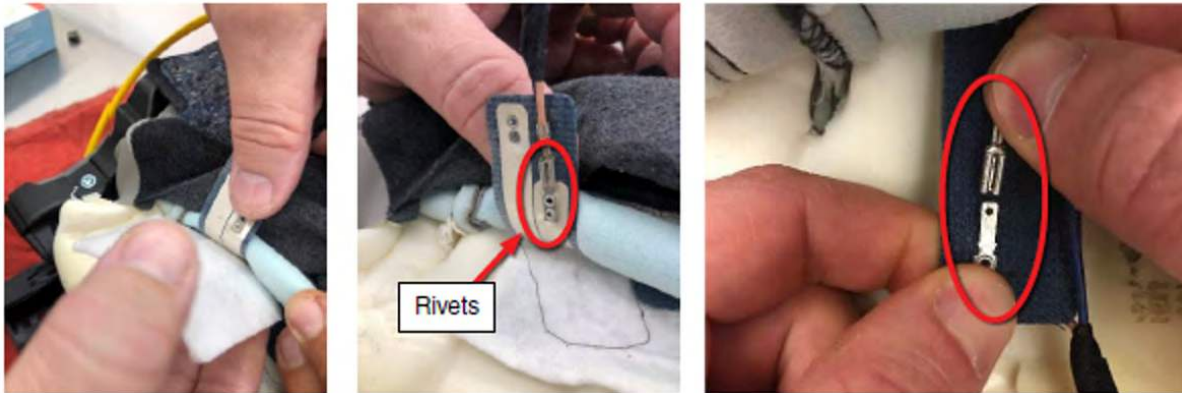
**STEP 9: IMPORTANT:** Always squeeze the tail terminals firmly at the rivets when disconnecting / reconnecting the harness terminals. Connect the new harness terminals to the sensor mat removing **ONE CONNECTION AT A TIME** to make sure they are reconnected in the proper configuration.

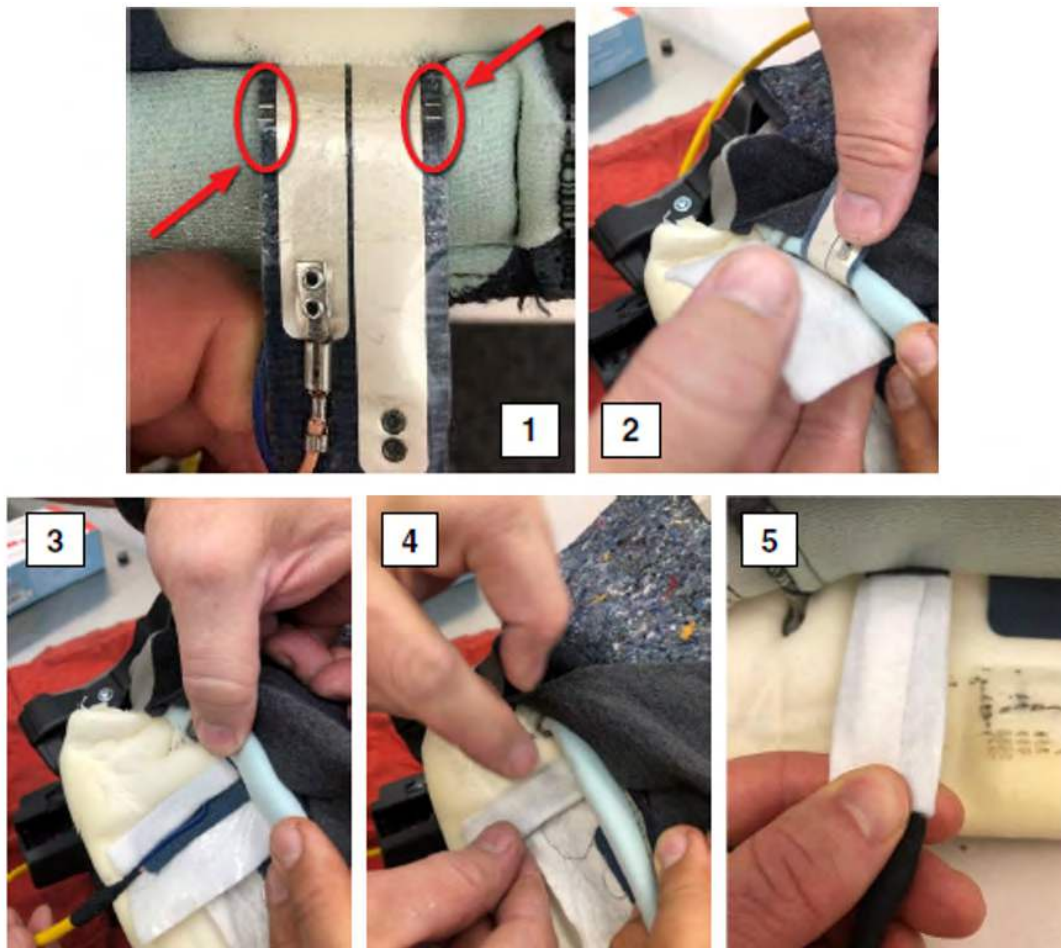
**STEP 10:** After connecting the new harness, place the new self-adhesive padding under the tail as shown (adhesive side up). Align the edge of the new padding with the two small, white registration marks on the tail as shown in (1) below. Peel the adhesive backing (2) and **CAREFULLY** apply the tail to the padding. Fold each side over (3) & (4) to recover it while being very careful to not create any wrinkles in the padding material.

When completed, squeeze the padding material (5) from one end to the other between fingers to ensure it is fully adhered.

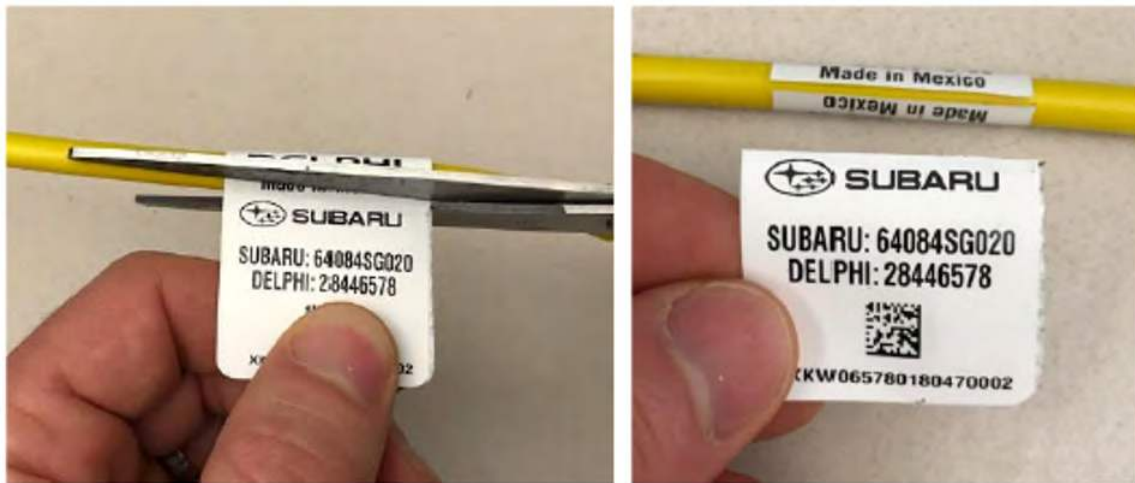
**STEP 11:** Use a pair of scissors to cut the harness label from the original (removed) wiring harness.

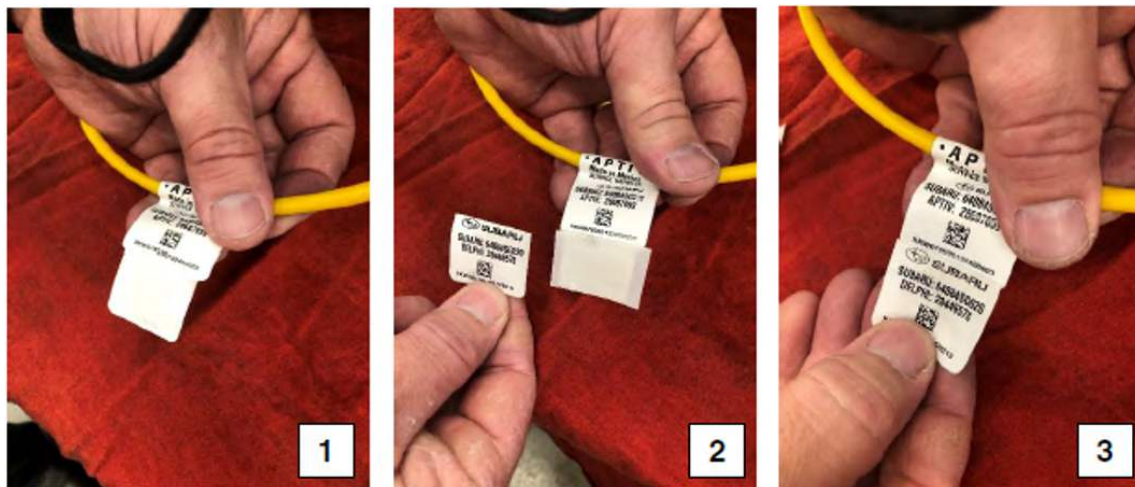
**STEP 12:** Remove the adhesive backing and apply the cut off section of the original label to the new replacement harness as shown in the photo sequence below.
