# Technical product information

| <b>Topic</b> | New Continental GT and GTC - Window drop glass operation |
| <b>Transaction No.</b> | 2070497/8 |

Retailer glass reset procedure for GT/GTC

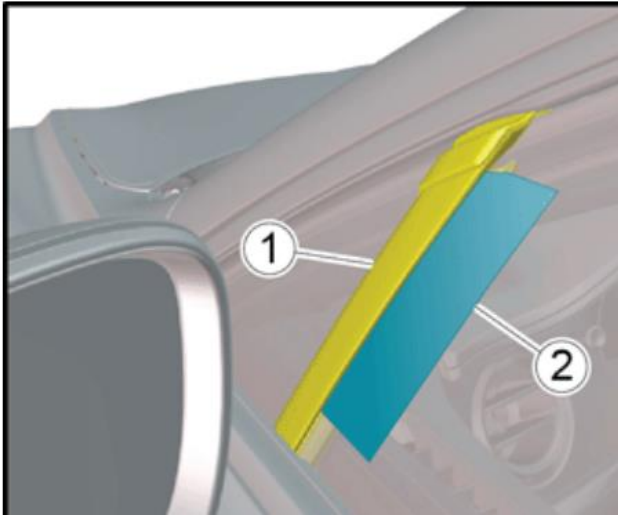
- **Measuring front glass intrusion into front division bar**

Example of incorrect fitment:  
10mm intrusion into division bar seal not achieved. Only 6mm seen, front and rear side glasses will be too far rearwards, potentially clash condition between rear of rear glass and cant rail/roof seals

When reinstalling front drop glass ensure tape is applied at 10mm from front edge and align this with the previously set quarter glass division bar.
