# Service Bulletin

Bulletin No.: 24-NA-064

**Subject:** Malfunction Indicator Lamp (MIL) Illuminated - DTCs P0324 and/or P0116 Set — ECM Software Update

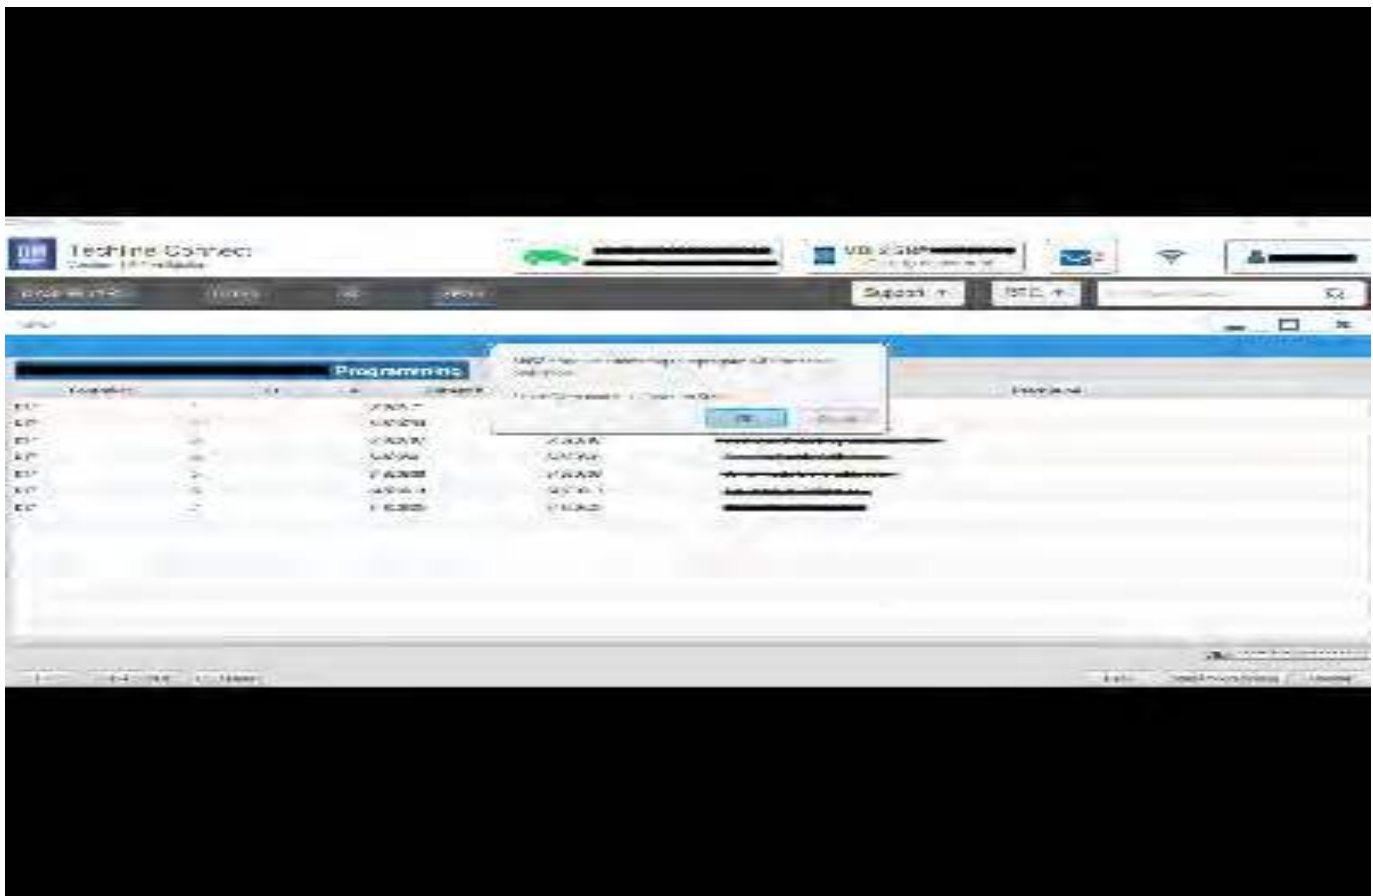
5644477

Important: Techline Connect screens shown above.

Important: If the same calibration/software warning is noted on the TLC Summary screen, select OK and follow screen instructions. After a successful programming event, the WCC is located in the Service Programming System dialogue box of the SPS Summary screen. No further action is required. Refer to the Warranty section of the bulletin.

1. Reprogram the Engine Control Module (ECM).  
Refer to K20 Engine Control Module: Programming and Setup in the Service Manual.
