| <b>HYUNDAI</b><br><b>Technical Service Bulletin</b> | GROUP<br><b>ENGINE</b> | NUMBER<br><b>24-EM-001H</b> |
| | DATE<br><b>JULY 2024</b> | MODEL(S)<br><b>SONATA (DN8a)<br/>SANTA FE (TMa)<br/>TUCSON (NX4a)</b> |
| <b>SUBJECT:</b> DTC P2181 – INTEGRATED THERMAL MANAGEMENT (ITM) REPLACEMENT | | |

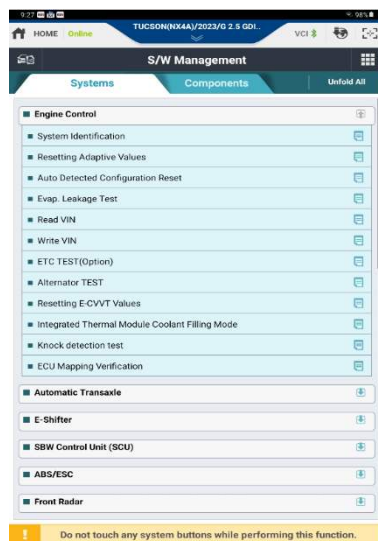
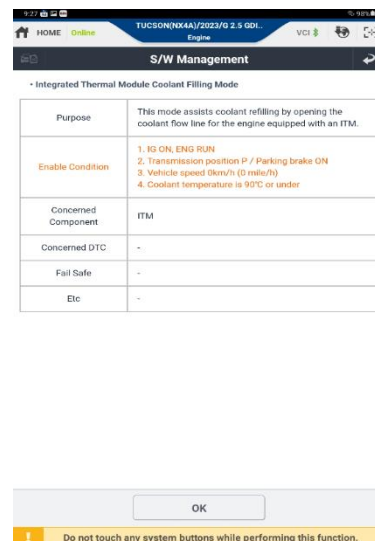
**NOTE:** Follow the steps below to perform “ITM Coolant Filling Method” with the GDS.

4. Perform an All-Systems Fault Code search and erase the history of the DTC that may have incidentally occurred.
5. Start the vehicle and then perform the ITM Coolant Filling Method to fully air bleed the cooling system using the GDS to enter the “Integrated Thermal Module Coolant Filling Mode”.
