# Preliminary Information

## PIP5932D Information on Malfunction Indicator Lamp (MIL) Illuminated with Any Combination of DTCs P0521, P06DD or P06DE Setting

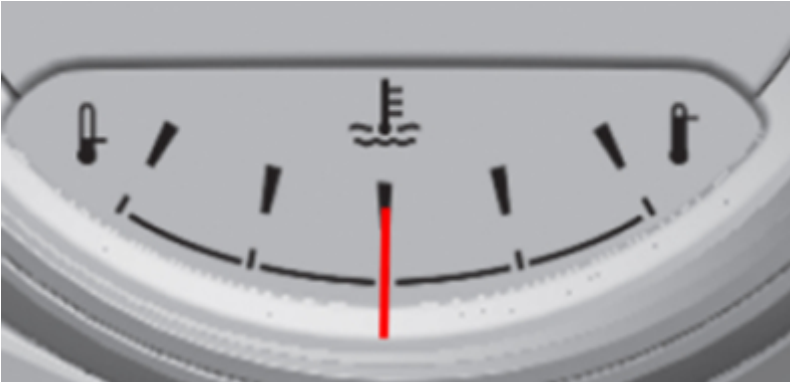
Module Diagnostics => [K20] Engine Control Module => Data Display => Engine Mechanical Data

Start and run engine for minimum 15 minutes until the coolant temperature gauge needle is centered in the gauge.
