# TECHNICAL SERVICE BULLETIN

| RS19-005D | ITB19-024D | September 19, 2024 |

## DTC B00A0-00 STORED

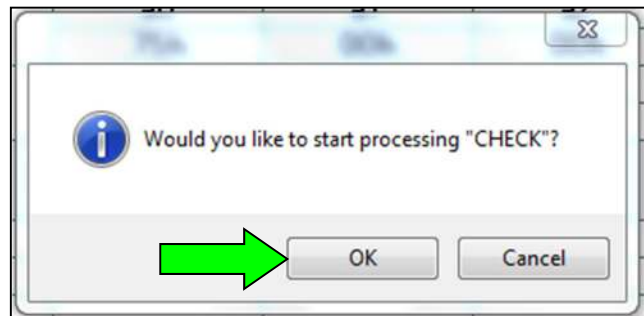
Figure 5

11. Check for code "75h" to show under **CURRENT FAILURE CODE**.

- If code "75h" shows under **CURRENT FAILURE CODE**, go to step 12.
- If code "75h" does not show under **CURRENT FAILURE CODE**, STOP HERE. This bulletin does not apply. Refer to ASIST and the ESM for further diagnostic assistance.

12. Select **75-Zero RESET**.

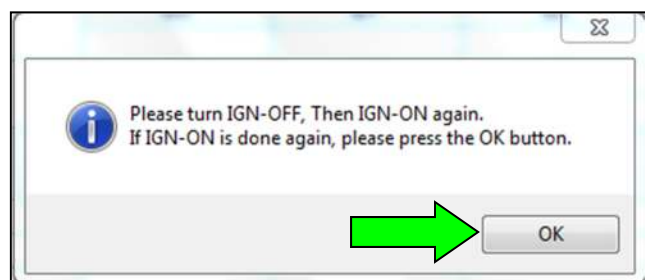
Figure 8

16. When the screen in Figure 9 displays, the 75-Zero reset process is complete.
  - Verify code “75h” is not displayed under **CURRENT FAILURE CODE**.
17. Select either **EXIT** or the
