# Service Bulletin

Bulletin No.: 24-NA-200

**Subject: DTC HPCM2 Software Update for Using NACS DC Fast Charge Adapter, Possible DTC(s) P3013 or P302D**

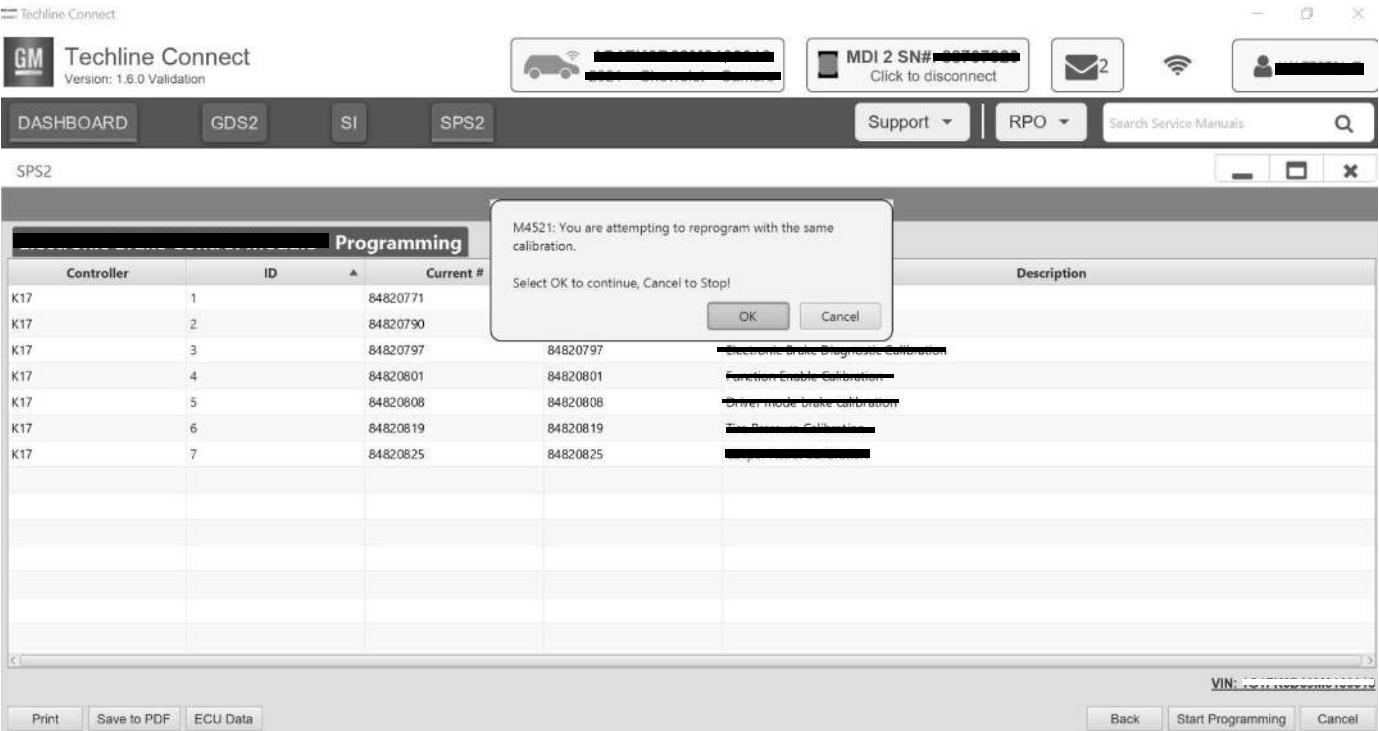
5644477

**Important:** Techline Connect screen shown above.

**Important:** If the same calibration/software warning is noted on the TLC Summary screen, select OK and follow screen instructions. After a successful programming event, the WCC is located in the Service Programming System dialogue box of the SPS Summary screen. Record the WCC on the job card. No further action is required. Refer to the Warranty Information section of this bulletin.
