# Service Alert

| <b>Subject:</b><br>MULTIPLE WARNING LIGHTS ON, VEHICLE ONLY STARTS WITH KEY TRANSMITTER NEAR START BUTTON DUE TO POOR CONTACT AT FUSE F1 | <b>Service Alert No.:</b> SA-040/24 |

2024-2025 CX-90  
2025 CX-70

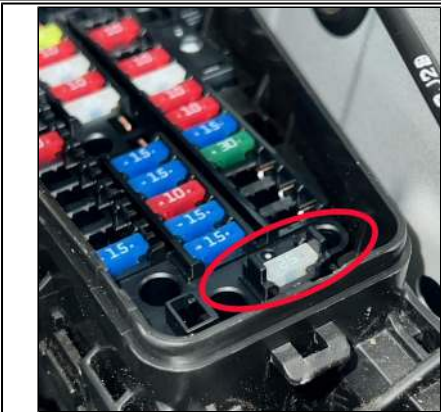
This may be caused by Fuse F1 not fully seated (poor terminal tension) or a poor ground connection at the front harness connector G03.
