# Service Bulletin

Bulletin No.: 24-NA-278

**Subject: BCM Software Update Needed – DTC B1AAE.13: Passive Entry Closure 2 Antenna Circuit High - Circuit Open**

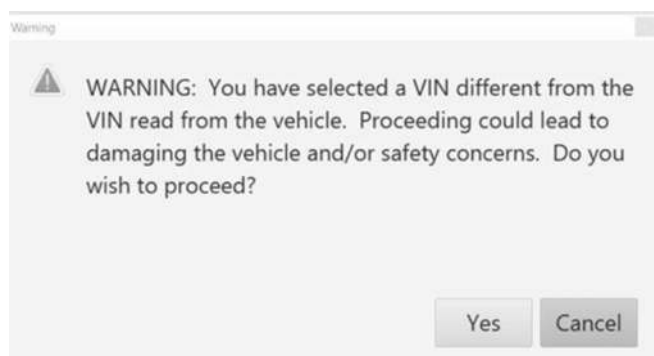
5877000

**Important:** If the vehicle VIN DOES NOT match, the message below will be shown.

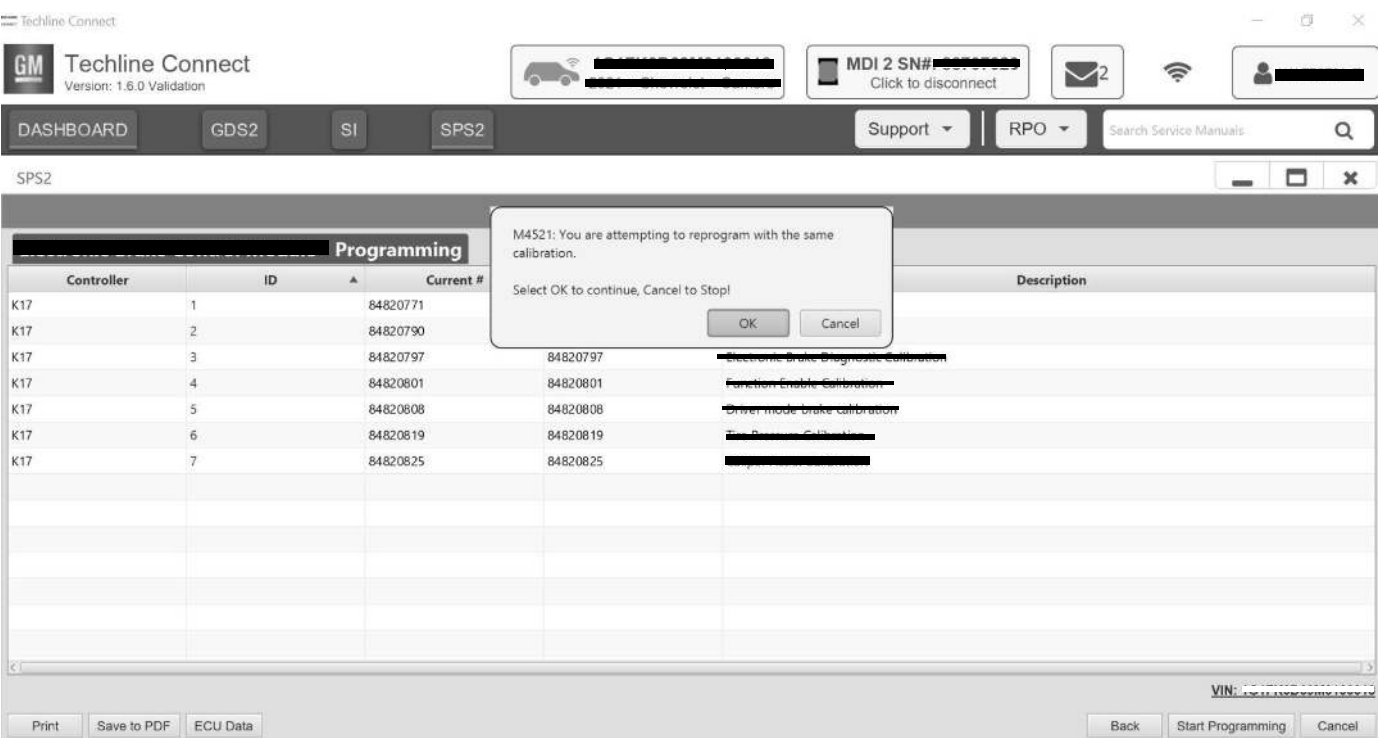
**Important:** Techline Connect screens shown above.
