Bulletin No.: PIP5240B
Published date: 02/1/2017

PIP5240B Mil On With DTC P0171 And / Or P1101

Models

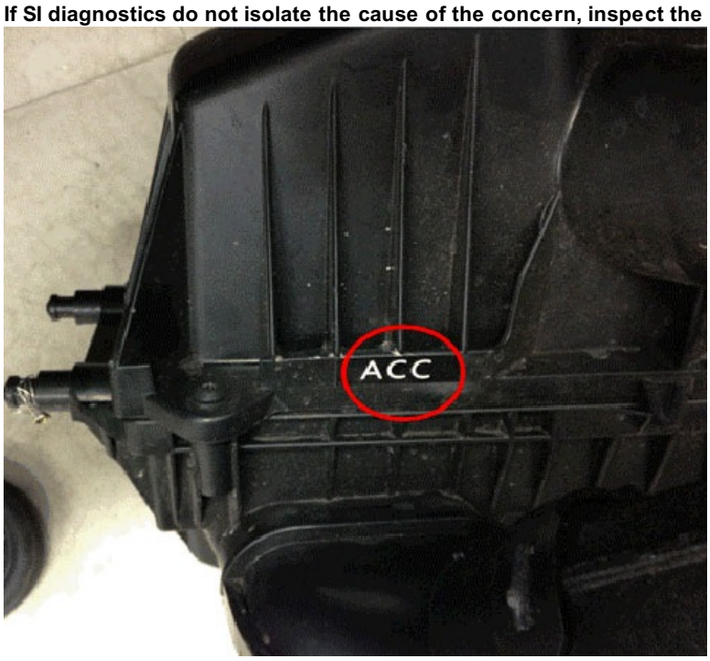
If SI diagnostics do not isolate the cause of the concern, inspect the ID code on the Air Cleaner Housing. (See photo below).

The correct application for the 2013-2015 Buick Encore and 2013-2015 Chevrolet Trax will have an ID code of ACD and will be fitted with a Hydro Carbon Absorber as shown below.

If the Hydro Carbon Absorber is missing, or the ID code is other than ACD, replace the Air Cleaner Housing with the latest listing in the Electronic Parts Catalog.

If the Hydro Carbon Absorber is present and the ID code is ACD, refer back to current SI diagnostics.
