Subject: UPDATE: N232421261 - Service Update  
False DTC Causing Unnecessary Battery Pack Replacements (NACS  
Adapter)  
Population Expansion

Models: 2020-2022 Chevrolet Bolt EV  
2020-2022 Chevrolet Bolt EUV

### N232421261 False DTC Causing Unnecessary Battery Pack Replacements (NACS Adapter)

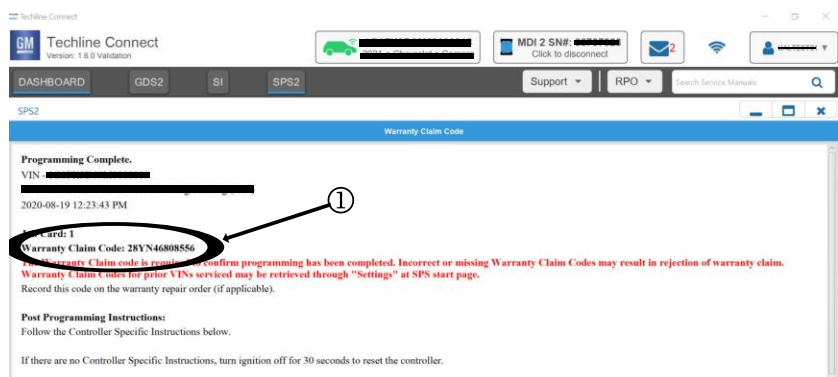
5644478

**Note:** The screenshot above is an example of module programming and may not be indicative of the specific module that is being programmed. Module selection and VIN information have been blacked out.
