Technical Service Bulletin

57 Remote control key low battery voltage warning in DIS (DTC B147918)

57 15 08 2039814/2 March 6, 2015. Supersedes Technical Service Bulletin Group 57 number 15-07 dated February 13, 2015 for reasons listed below.

Model(s)	Year	VIN Range	Vehicle-Specific Equipment
A3	2015	All	Not Applicable

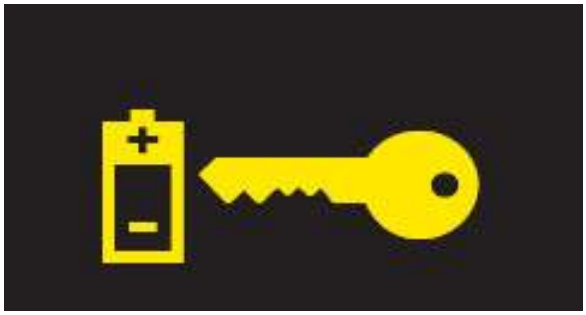
- A remote key low battery warning icon and the warning message “Please change key battery” appear in the instrument cluster (Figure 1).
- **DTC B147918** (Remote key 1 voltage too low) is logged in the vehicle electrical system control module (BCM1), J519 (address word 09).
- The remote key battery is correct.

Figure 1. *Warning icon in instrument cluster for remote key low battery.*

Incorrect diagnostics for determining low remote key battery voltage in the software of the vehicle electrical system control module (BCM1).

There is no need to replace the remote key battery if it tests greater than 3.0V.

1. Update the software and parameters of the vehicle electrical system control module (BCM1) using the instructions below. The parameter part number and version can only be seen after the SVM code completes.
2. After the software update is complete, test by unlocking and starting the vehicle multiple times to ensure that the low battery warning does not return.

1. Follow all instructions in TSB 2011732, *00 Software Version Management (SVM), operating instructions*.
2. Update the J519 control module (address word 09) using the SVM action code as listed in the table below, if necessary.
