# Service Bulletin

Bulletin No.: 25-NA-026

**Subject: Service Drivers Assist Message Illuminated, Super Cruise Inoperable, and DTC U1624 Setting**

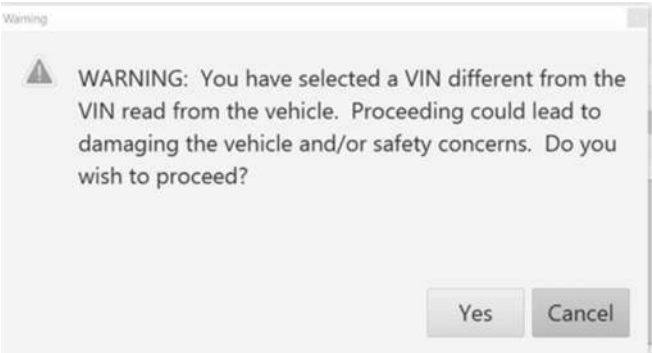
5877000

**Important:** If the vehicle VIN DOES NOT match, the message below will be shown.
