**PHEV - Vehicle Inspection Procedure and Preparation for Repair**

## Section B: Repair Procedure Recall 7325C

EMISSIONS RECALL 7325C  
PHEV VEHICLE REPAIR PROCEDURE

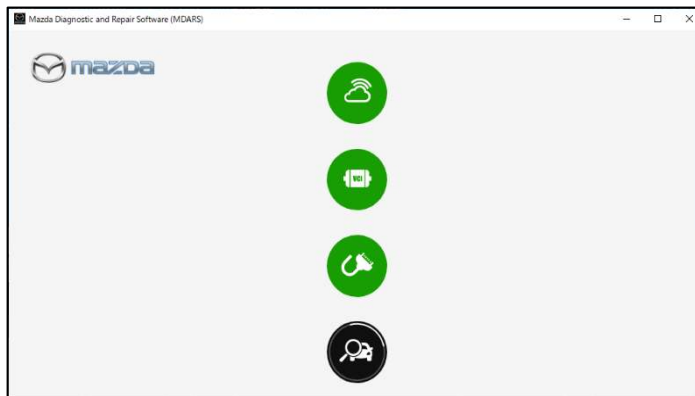
3. The Vehicle Identification process will start and automatically inspect every connection and then collect the vehicle information.

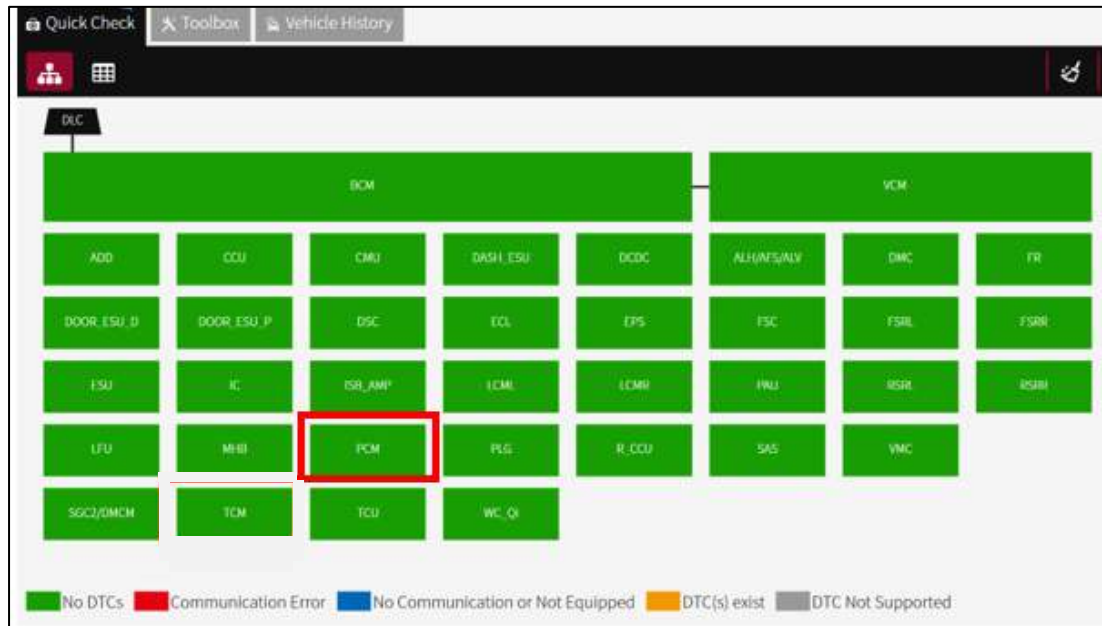
9. Confirm with Quick Check the PCM are highlighted in Green after updating the modules.

**NOTE: If any DTCs exist in yellow follow the Workshop Manual or applicable TSB for the concern.**

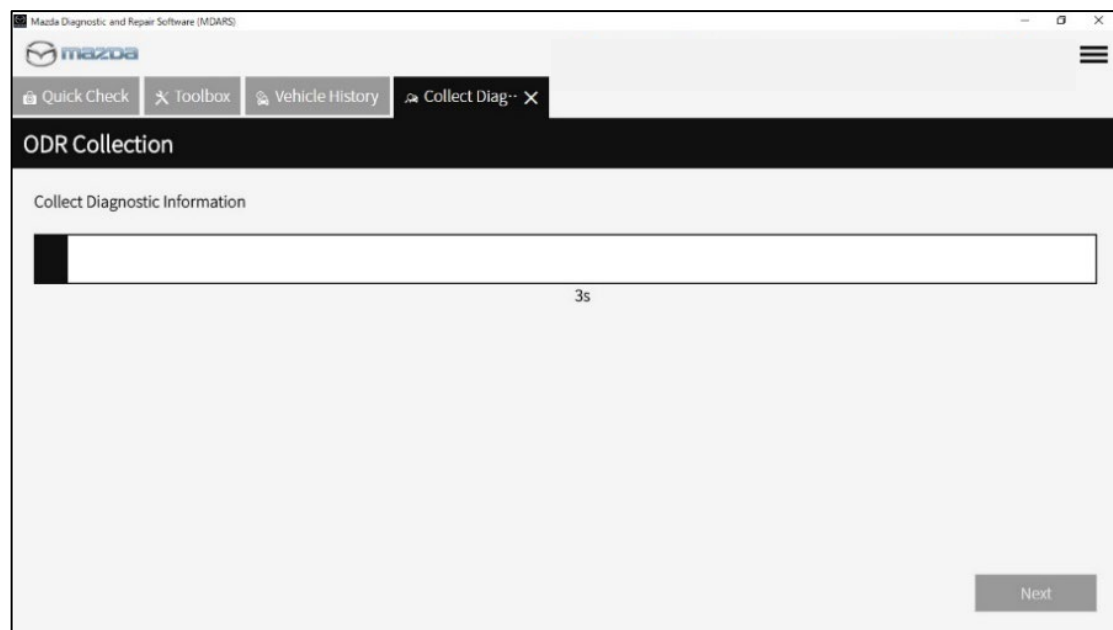
(3) It takes around 60 seconds.

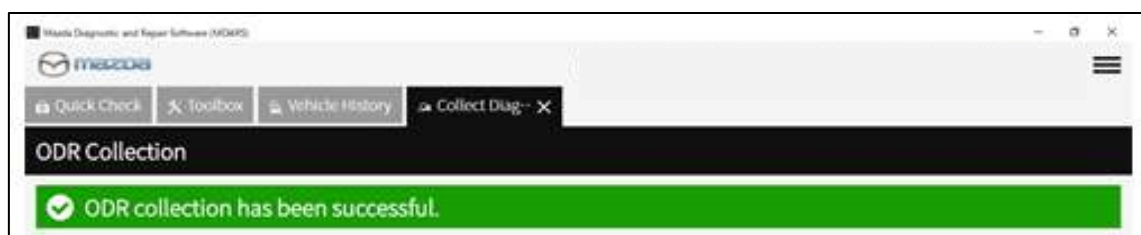
(4) MDARS will collect ODR and send to the server.

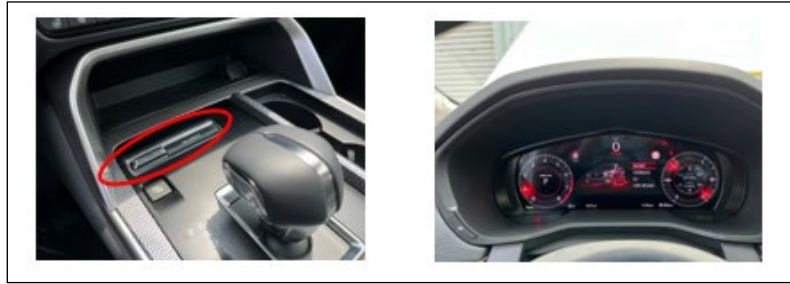
24. Switch to 'Sport Mode'
