| <br><small>JX</small><br><b>Technical Service Bulletin</b> | <b>GROUP</b> | <b>NUMBER</b> |
| | <b>BODY ELECTRICAL</b> | <b>25-BE-007G</b> |
| <b>SUBJECT:</b> FRONT RADAR SOFTWARE UPDATE FOR DTC C1620 | | |

**Description:** Certain 2021-2023MY GV80 (JX1), 2022-2023MY GV70 (JK1), 2021-2023MY G80 (RG3) and 2023MY G80 Electrified (RG3 EV) vehicles may exhibit a warning light with DTC C162078 due to improper detection of steel structures.

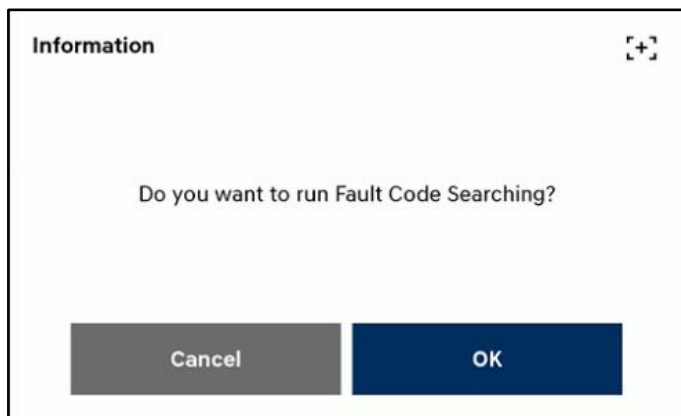
5. Perform an **All Systems Fault Code** search and erase DTC history that had incidentally occurred from the ECU update.
