2025MY  
K5 (DL3)

SERVICE ACTION: ACU OPERATION  
LOGIC IMPROVEMENT (SA609)

This bulletin provides information to upgrade the Airbag Control Unit 'ACU' system software on certain 2025MY K5 (DL3) vehicles produced from February 20, 2024 to October 25, 2024. In rare cases when the driver restarts the vehicle within 1.5 seconds after turning the ignition 'OFF', the affected vehicles may exhibit the "ESC/Forward Collision Avoidance System" warning light(s) illuminating for up the three (3) minutes with DTC(s) C128387 and/or C164286 stored. During this time, Electronic Stability Control 'ESC', Forward Collision—Avoidance Assist 'FCA' and Lane Keeping Assist 'LKA' functions are inoperable. Follow the procedure outlined in this publication to apply the improved logic to the 'ACU' system using the KDS ECU Upgrade function as described in this bulletin. Refer to [SST081](#) for software upgrade instructions using Kia Diagnostic System (KDS) tablet and VCI-II and confirm the Upgrade Event Number/Name, ROM ID Information, and Manual Mode passwords (if applicable) on the applicable vehicle.

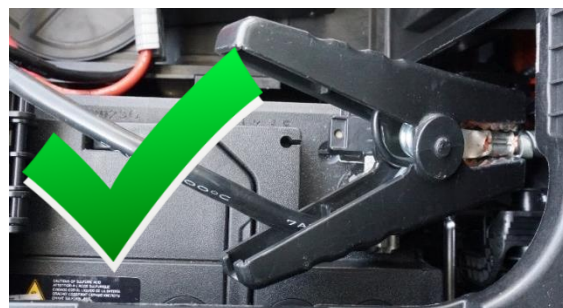
[Connect the negative \(-\) terminal to the battery as shown below.](#)
