Subject: REVISION: N242487960-01 – Service Update  
BCM DTC U1962 May Not Properly Clear  
2024 Model Year Added

Models: 2024-2025 Chevrolet Corvette

### N242487960 BCM DTC U1962 May Not Properly Clear

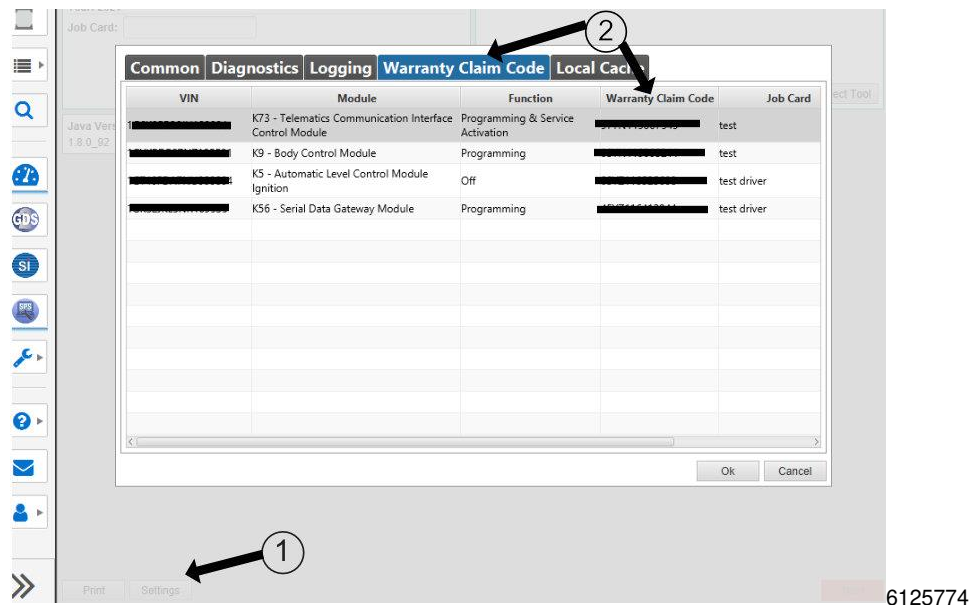
If the Warranty Claim Code was not recorded on the Job Card, the code can be retrieved in the SPS2 system as follows:

1. Open TLC on the computer used to program the vehicle.
2. Select and start SPS2.
3. Select Settings (1).
4. Select the Warranty Claim Code tab (2).

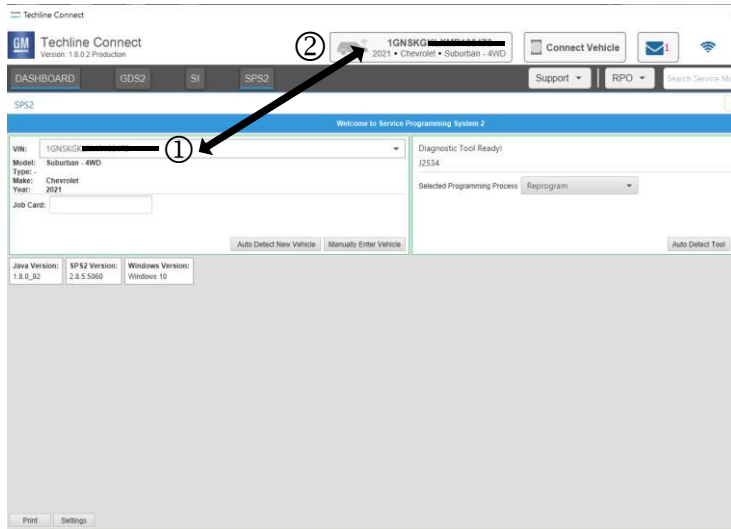
5743643

**Caution:** Be sure the VIN selected in the drop down menu (1) is the same as the vehicle connected (2) before beginning programming.

**Important:** Techline Connect screens shown above.

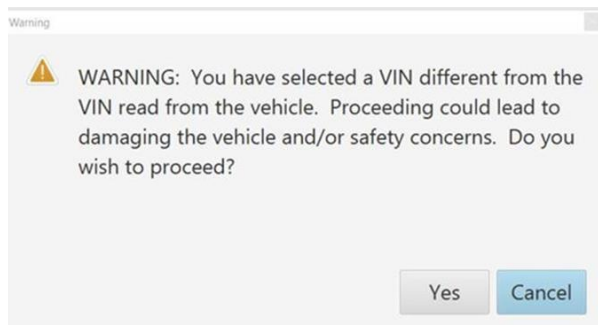
5877000

**Important:** If the vehicle VIN DOES NOT match, the message below will be shown.

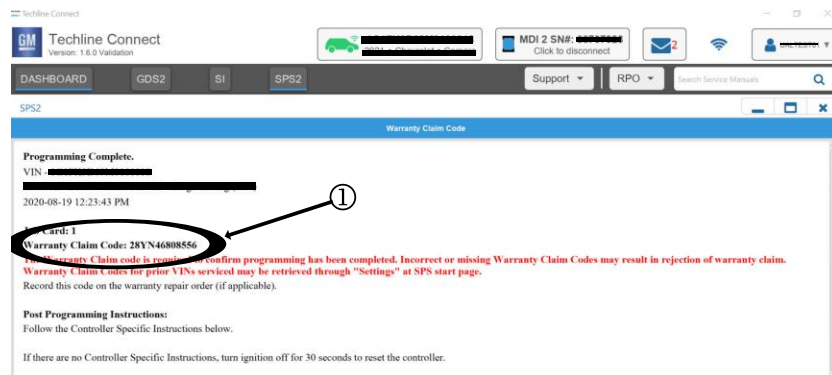
5644478

1. Reprogram the Body Control Module. Refer to *K9 Body Control Module: Programming and Setup* in SI.

**Note:** The screenshot above is an example of module programming and may not be indicative of the specific module that is being programmed. Module selection and VIN information have been blacked out.

**Important:** If the same calibration/software warning is noted on the TLC Summary screen, select OK and follow screen instructions. After a successful programming event, the WCC is located in the Service Programming System dialogue box of the SPS Summary screen. No further action is required. Refer to the Warranty section of the bulletin.
