## Section B: Repair Procedure Recall 7325C

### Reprogram PCM by MDARS

EMISSIONS RECALL 7325C  
PHEV VEHICLE REPAIR PROCEDURE

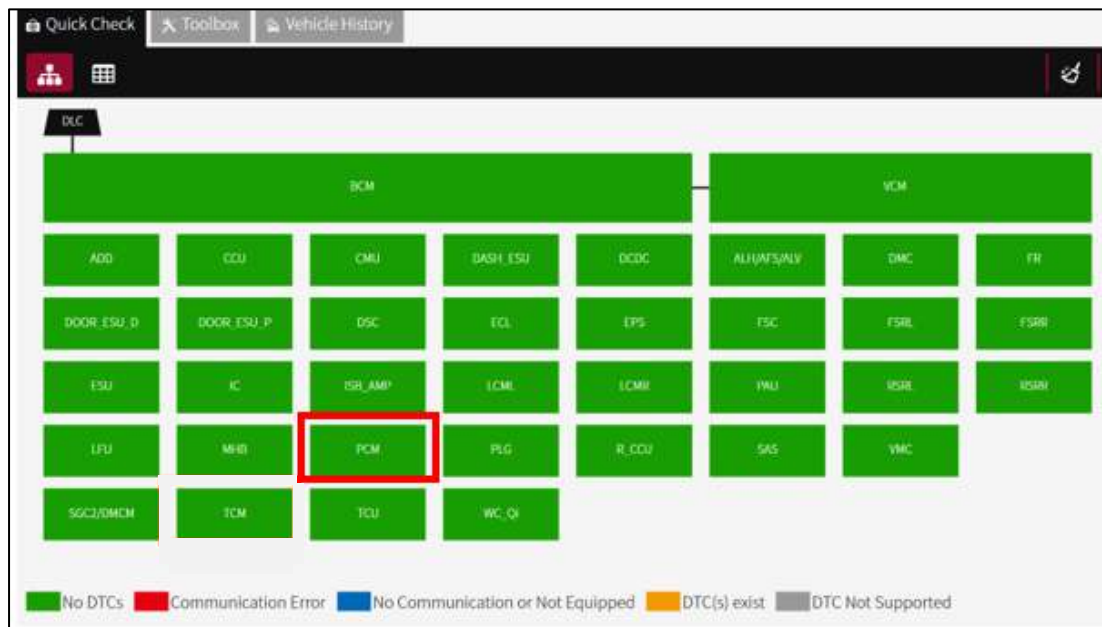
9. Confirm with Quick Check the PCM are highlighted in Green after updating the modules.

**NOTE: If any DTCs exist in yellow follow the Workshop Manual or applicable TSB for the concern.**

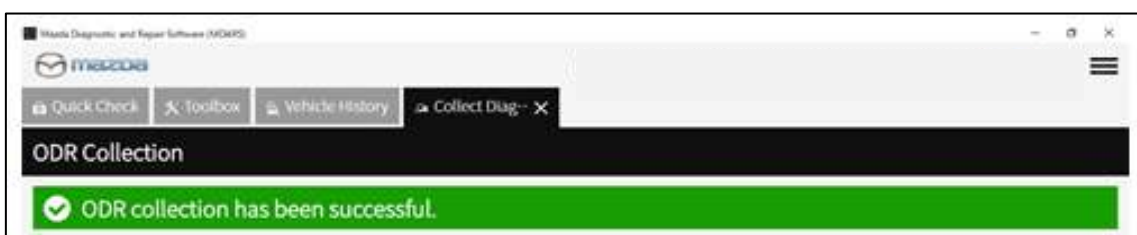
(4) MDARS will collect ODR and send to the server.

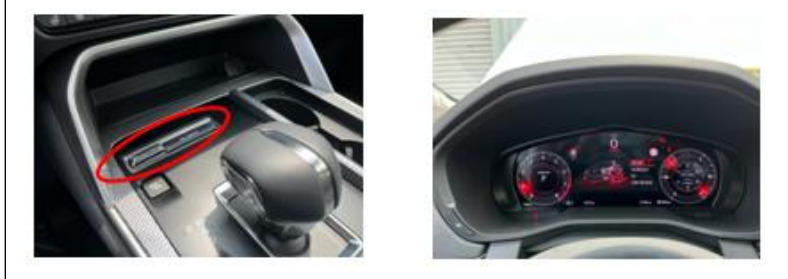
24. Switch to 'Sport Mode'
