## Technical Service Bulletin (TSB)

### DXR USB Update to v1.4.160 For MIM Radio

| REFERENCE: | TSB: 08-191-25<br>GROUP: 08 - Electrical | Date: | June 13, 2025 | REVISION: | — |
| VEHICLES AFFECTED: | 2024 (LB) Dodge Charger<br>This bulletin applies to vehicles equipped with a 400V G2300 FR/RR Elec Drive Motors (Sales Code ELJ) with Drive eXperience Recorder (Sales Code JFC) and Drive eXperience Recorder Prep (Sales Code JGB) with Uconnect 5 Nav W 12.3" Display (USA) (Sales Code UBX) or Uconnect 5 Nav W 12.3" Display (CAN) (Sales Code UEX). | | | MARKET APPLICABILITY:<br><div><input checked="" type="checkbox"/> NA<input type="checkbox"/> MEA</div> <div><input type="checkbox"/> SA<input type="checkbox"/> IAP</div> <div><input type="checkbox"/> EE<input type="checkbox"/> CH</div><br><b>NOTE:</b> This bulletin applies to the North America market. | |

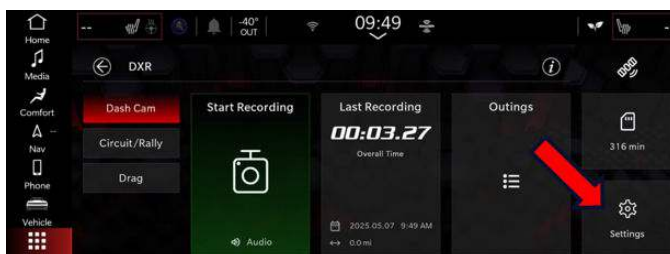
**Fig. 4**  
Settings

7. Click the Settings button to open the settings menu [Fig. 4](#).

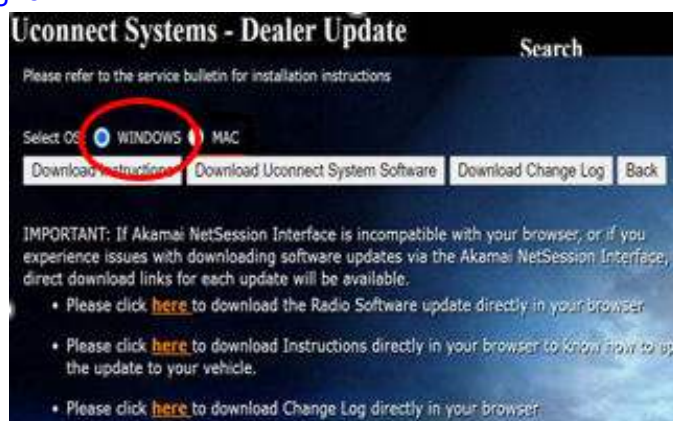
**Fig. 8**

15. Download the software update file to your local PC's desktop. Make sure to select the “WINDOWS” radial button for all downloads [Fig. 8](#).

### WINDOWS Download Steps

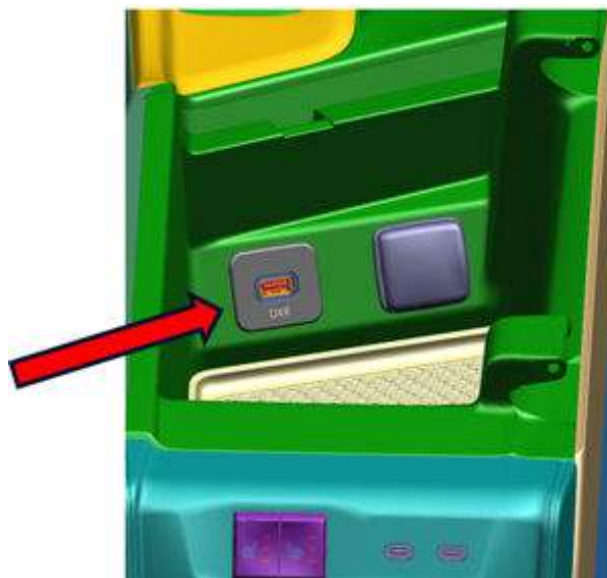
**Fig. 10**  
DXR USB

22. Start the vehicle and insert the USB flash drive into the DXR USB port [Fig. 10](#).

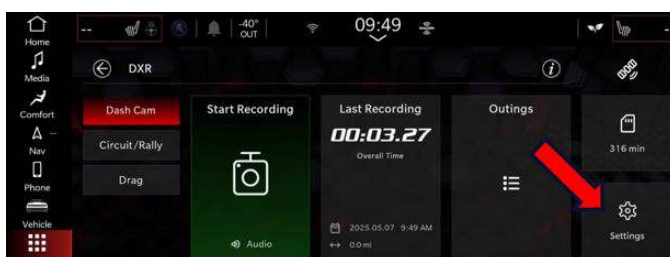
**Fig. 14**  
Settings

27. Click the Settings button to open the settings menu [Fig. 14](#).
