## Technical Service Bulletin (TSB)

### DXR USB Update to v1.4.160 For MIM Radio

| VEHICLES AFFECTED: | 2025 (LB) Dodge Charger<br>This bulletin applies to vehicles equipped with a 400V G2300 FR/RR Elec Drive Motors (Sales Code ELJ) with Drive eXperience Recorder (Sales Code JFC) and Drive eXperience Recorder Prep (Sales Code JGB) with Uconnect 5 Nav W 12.3" Display (USA) (Sales Code UBX) or Uconnect 5 Nav W 12.3" Display (CAN) (Sales Code UEX). | | | MARKET APPLICABILITY:<br><div><input checked="" type="checkbox"/> NA<input type="checkbox"/> MEA</div> <div><input type="checkbox"/> SA<input type="checkbox"/> IAP</div> <div><input type="checkbox"/> EE<input type="checkbox"/> CH</div><br><div>NOTE: This bulletin applies to the North America market.</div> | |

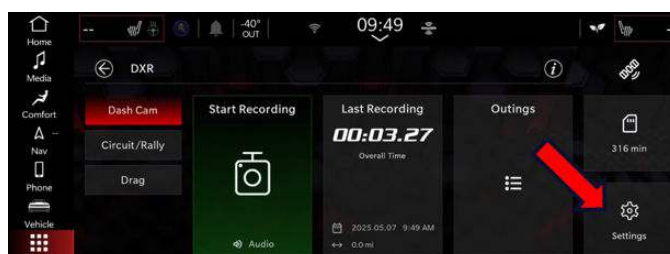
**Fig. 4**  
Settings

7. Click the Settings button to open the settings menu [Fig. 4](#).

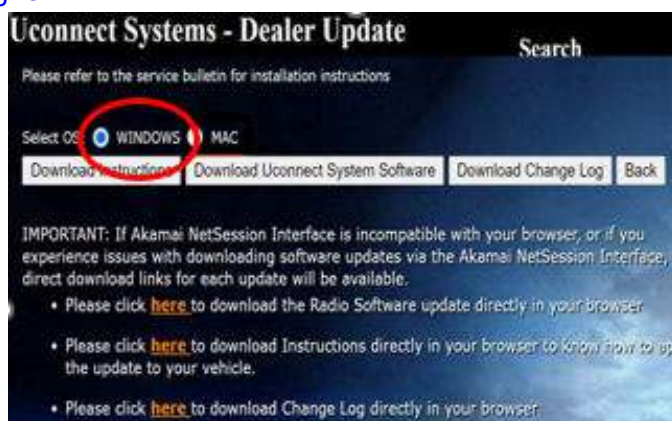
**Fig. 8**

15. Download the software update file to your local PC's desktop. Make sure to select the “WINDOWS” radial button for all downloads [Fig. 8](#).

WINDOWS Download Steps
