# Service Bulletin

Bulletin No.: 24-NA-138

**Subject: Forward Collision Alert Unavailable DIC Message with U3000 SYM44 in Front Camera Module**

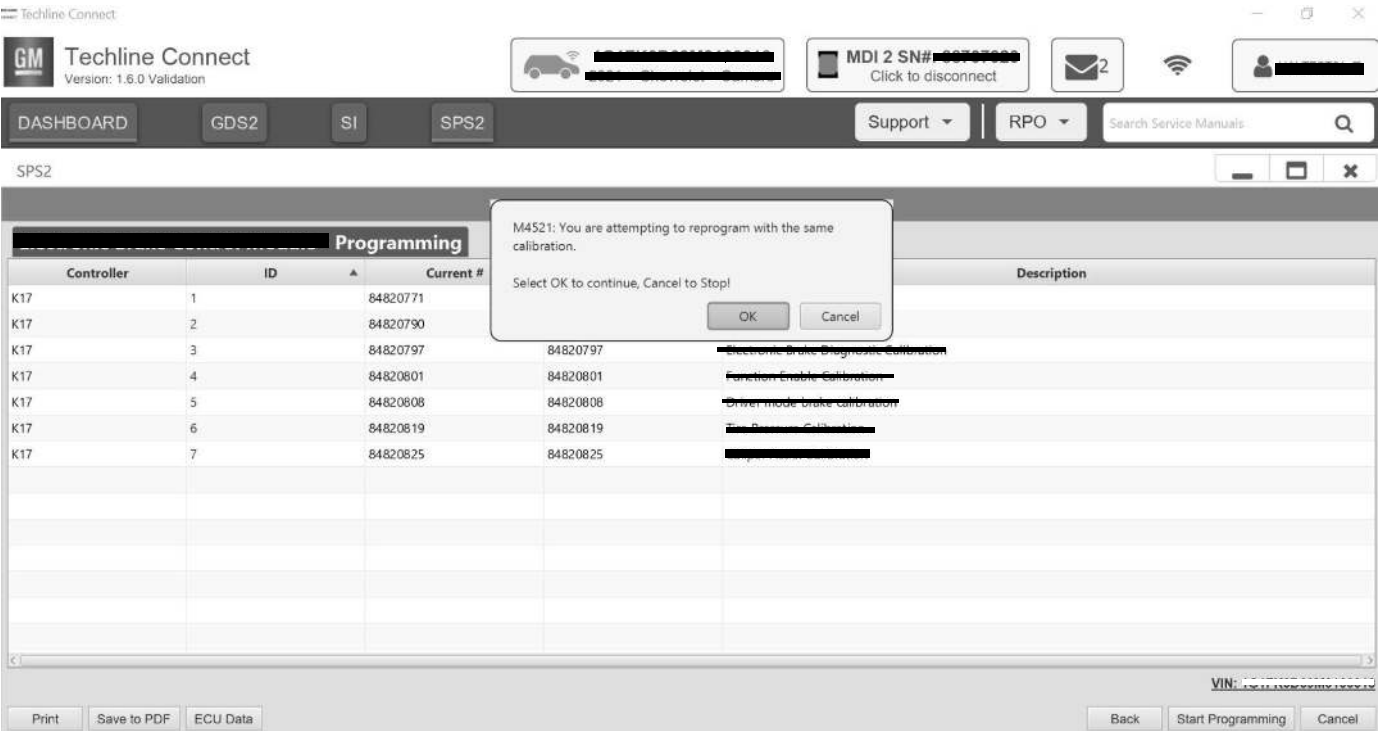
5644477

**Important:** Techline Connect screen shown above.

**Important:** If the same calibration/software warning is noted on the TLC Summary screen, select OK and follow screen instructions. After a successful programming event, the WCC is located in the Service Programming System dialogue box of the SPS Summary screen. Record the WCC on the job card. No further action is required. Refer to the Warranty Information section of this bulletin.

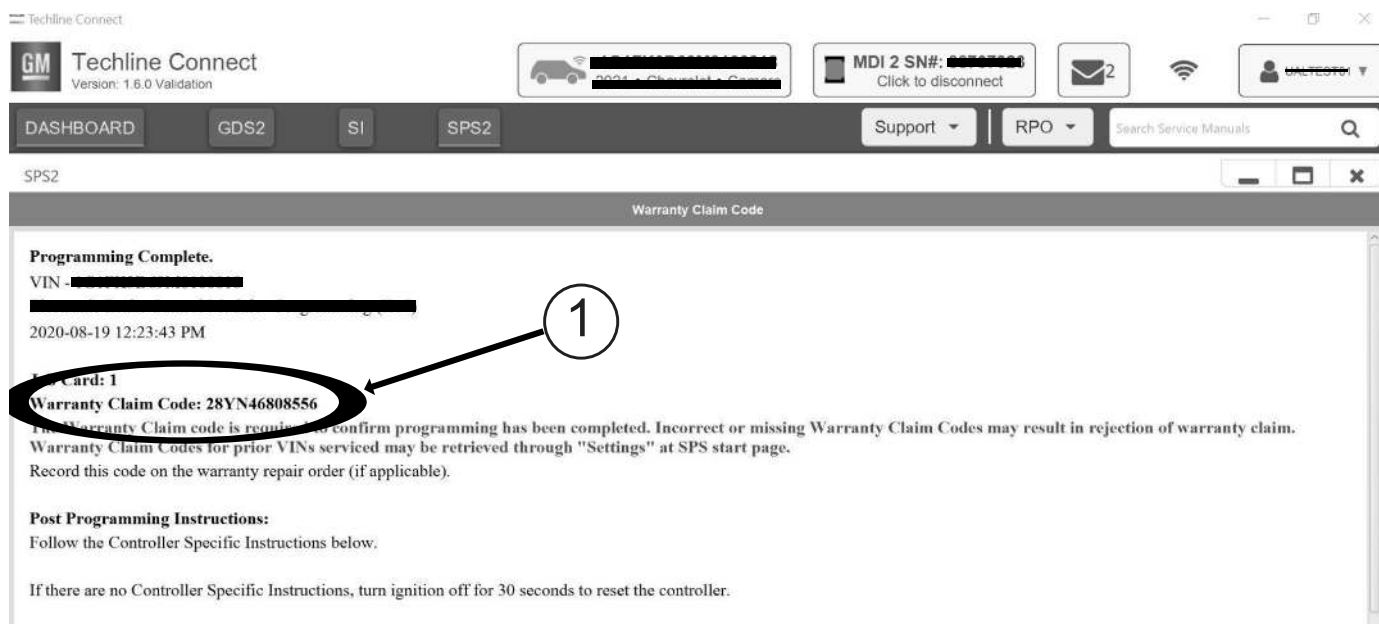
5644478

**Note:** The screenshot above is an example of module programming and may not be indicative of the specific module that is being programmed. Module selection and VIN information have been blacked out.

1. Reprogram the B174W Front View Camera Module. Refer to *B174W Frontview Camera - Windshield: Programming and Setup* in SI. Then, perform FCM Service Learn (SPC) using GDS and Clear DTCs to ensure issue is resolved.
