| REFERENCE: | TSB: 18-031-25 REV. B<br>GROUP: 18 - Vehicle Performance | Date: | September 27, 2025 | REVISION: | 18-031-25 REV. A |
| VEHICLES AFFECTED: | 2025 (DT) RAM 1500 Pickup<br>This bulletin applies to vehicles built on or before May 08, 2025 (MDH 0508XX) equipped with 3.0L I6 Hurricane SO Twin Turbo ESS (Sales Code EFH). | | | MARKET APPLICABILITY:<br><div><input type="checkbox"/> NA<input type="checkbox"/> MEA</div> <div><input type="checkbox"/> SA<input type="checkbox"/> IAP</div> <div><input type="checkbox"/> EE<input type="checkbox"/> CH</div><br>NOTE: This bulletin applies to the North and South America, Enlarged Europe, Middle East & Africa, India & Asia Pacific, China markets. | |
| CAUSE: | PCM software updates | | | | |

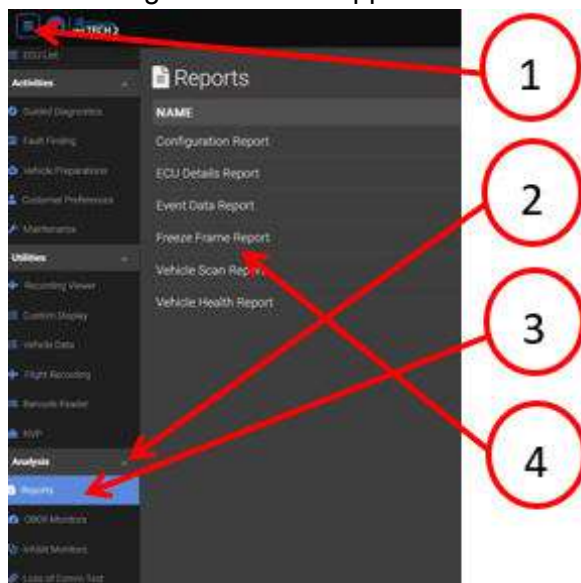
**Fig. 1**  
Navigate To Freeze Frame Report

- 1 - Hamburger Icon
- 2 - Analysis
- 3 - Reports
- 4 - Freeze Frame Report

1. \*\*Is the vehicle on the RSU VIN list?
  - YES >>> Proceed to [Step 10](#).
  - NO >>> Proceed to [Step 2](#).
2. Are DTCs P00C6-00, P0325-00, P0330-00, P032A-00, P018B-00, P2AF6-00 and/or U0104-00 and/or U0405-00 present in Active/Stored status?
  - YES >>> Proceed to [Step 10](#).
  - NO >>> Proceed to [Step 3](#).
3. Are DTCs P0300-00, P0301-00, P0302-00, P0303-00, P0304-00, P0305-00, and/or P0306-00 present in Active/Stored status?
  - YES >>> Proceed to [Step 4](#).
  - NO >>> This bulletin has been completed, use Inspect LOP (18-19-06-KF) to close the active RSU.
4. In the wiTECH tool, select the hamburger icon in the upper left corner [Fig. 1](#).

5. Navigate down to Analysis on the left column and select the drop down arrow [Fig. 1](#).
6. Select Reports [Fig. 1](#).
7. Select Freeze Frame Report [Fig. 1](#).
8. To confirm the cold start catalyst heating, use wiTech Freeze Frame data and confirm that DTCs P0300-00, P0301-00, P0302-00, P0303-00, P0304-00, P0305-00 and/or P0306-00 was set under following condition:
  - Engine Coolant Temperature °F less than 122°F (50°C) [Fig. 2](#).
  - Time Since Engine Start less than 30 seconds [Fig. 2](#).
