| <b>HYUNDAI</b><br><b>Technical Service Bulletin</b> | GROUP<br><b>CAMPAIGN</b> | NUMBER<br><b>25-01-068H</b> |
| <b>SUBJECT:</b> OIL PUMP UNIT (OPU) SOFTWARE UPDATE -<br>DTC U100787 (SERVICE CAMPAIGN TEK) | | |

**Description:** Certain Tucson Hybrid (NX4 HEV) and Tucson Plug-in Hybrid (NX4 PHEV) vehicles may exhibit a condition where the Oil Pump Unit (OPU) prevents the Ready Lamp from turning on. Some vehicles may also display DTC U100787 (malfunction on CAN communication). This bulletin provides instructions to update the Powertrain Control Unit (PCU) software.

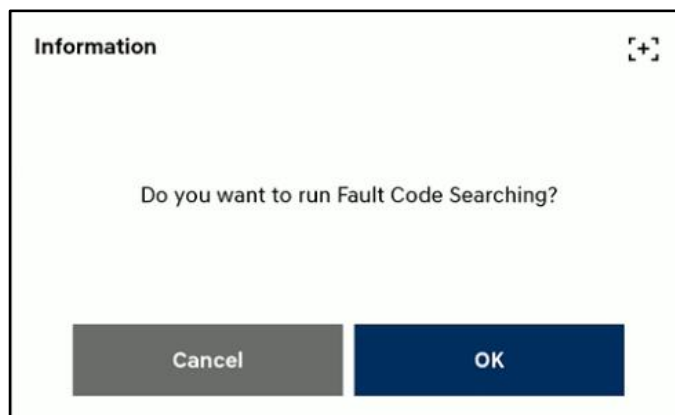
7. Perform an **All Systems Fault Code** search and erase DTC history that had incidentally occurred from the ECU update.
