## Technical Service Bulletin (TSB)

### DXR USB Update to v1.4.160 For MIM Radio

This bulletin involves inspecting and if required, updating the radio software level to 1.4.160.

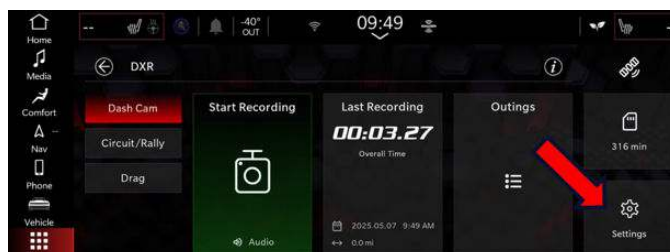
**Fig. 4**  
Settings

7. Click the Settings button to open the settings menu [Fig. 4](#).

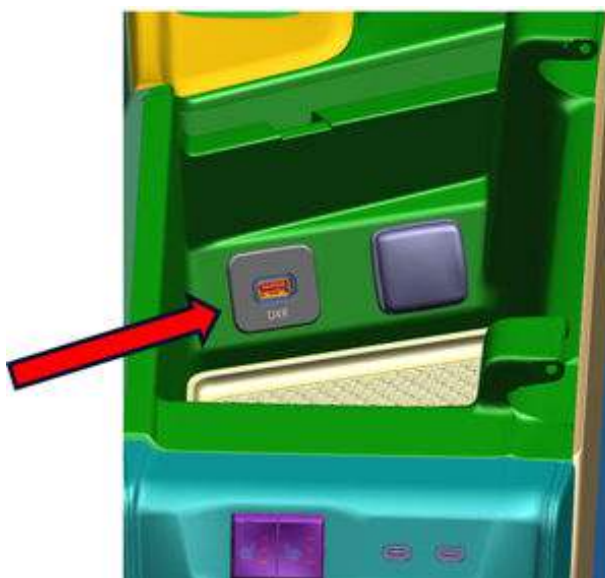
**Fig. 8**  
DXR USB

19. Perform the following steps to properly eject the USB flash drive [Fig. 9](#):
  - a. Right click on the location of the USB flash drive.
  - b. Click "Eject" to avoid data corruption.
  - c. Remove the USB flash drive from the PC.
20. Shut off all remaining accessories for the duration of the update (flashers, climate controls, etc.).
21. Wait for the radio to fully power on and initialize. Ensure all splash, partner logo, animation, disclaimer and main screens have loaded, before starting the software update.
22. **\*\*Install a 12v battery charger and insert the USB flash drive into the DXR USB port [Fig. 10](#).\*\***

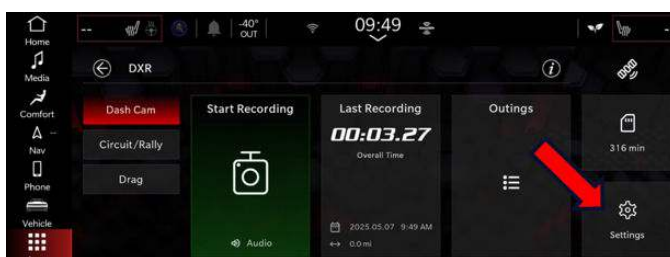
**Fig. 12**  
Settings

27. Click the Settings button to open the settings menu [Fig. 14](#).

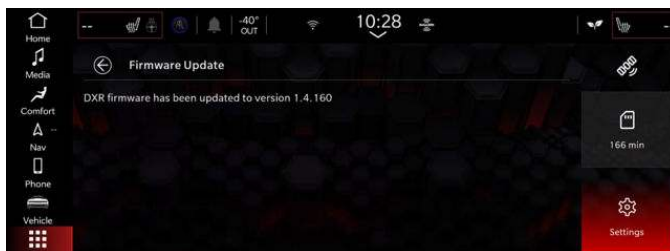
**Fig. 16**

31. This message will be displayed when the update is complete [Fig. 18](#).

### Software Updated Screen
