| Technical Journal Title<br>Propulsion Warning with IEM P0CBC62 | | Ref. No.<br>TJ 37521.1.0 | |
| Function Description<br>Electric converter, high voltage | | Page<br>Page 1 of 4 | |

## DESCRIPTION:

If a customer experiences a “Propulsion System Service Required” message in the DIM, and the DTC IEM P0CBC62 is stored, please follow the advice under “Service”.

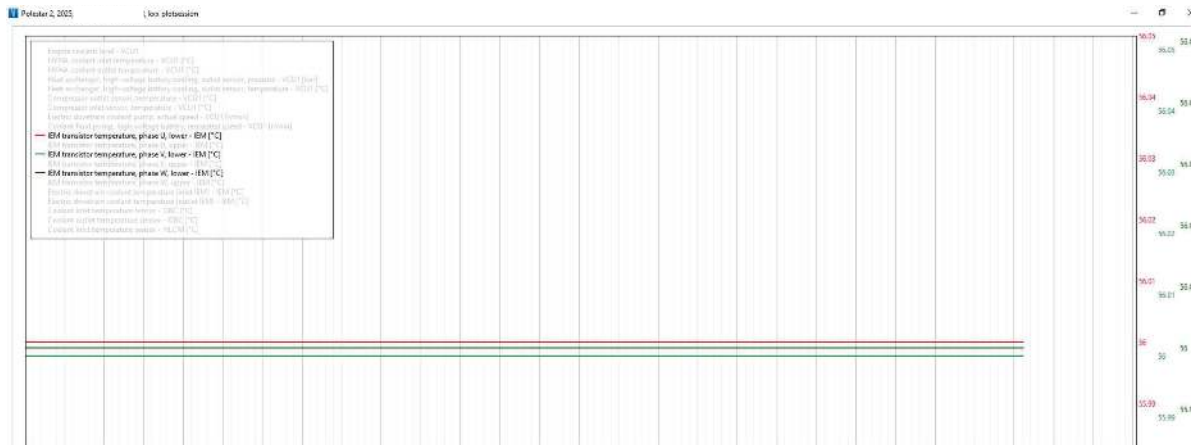
TJ 37521

## Technical Journal 37521.1.0

There have been cases where the IEM has been replaced incorrectly for this DTC, and instead, a faulty one-way valve in the coolant system was the root cause.

If the vehicle behaves as shown on page 3, replace the hose with the one-way valve to avoid unnecessary replacement of the IEM.
