# Service Bulletin

Bulletin No.: 23-NA-159

Subject: DTC P22FB/P22FE CALIBRATION UPDATE - REPROGRAM DEF CONTROL UNIT (DCU)

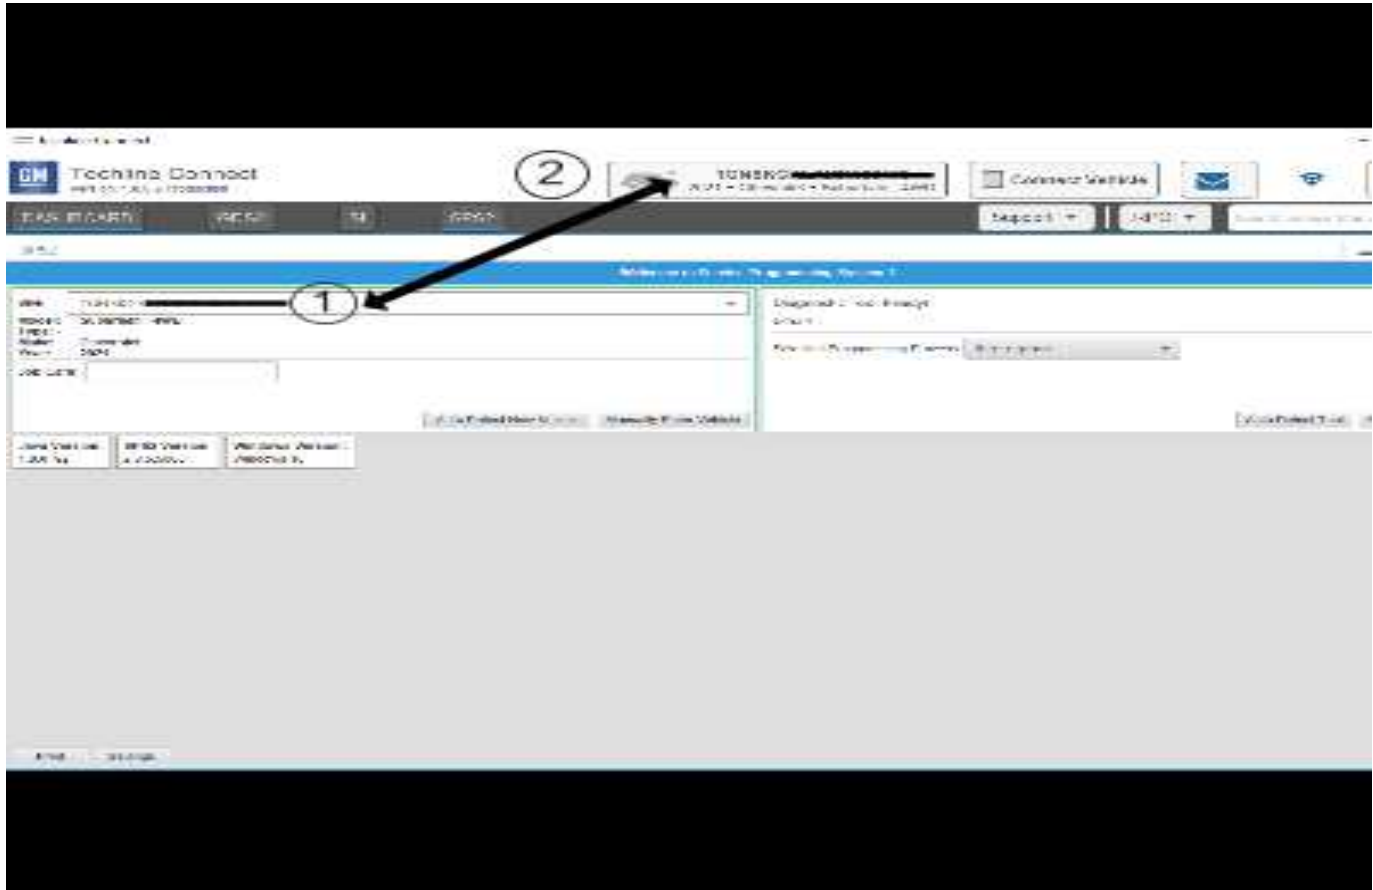
Caution: Be sure the VIN selected in the drop down menu (1) is the same as the vehicle connected (2) before beginning programming.

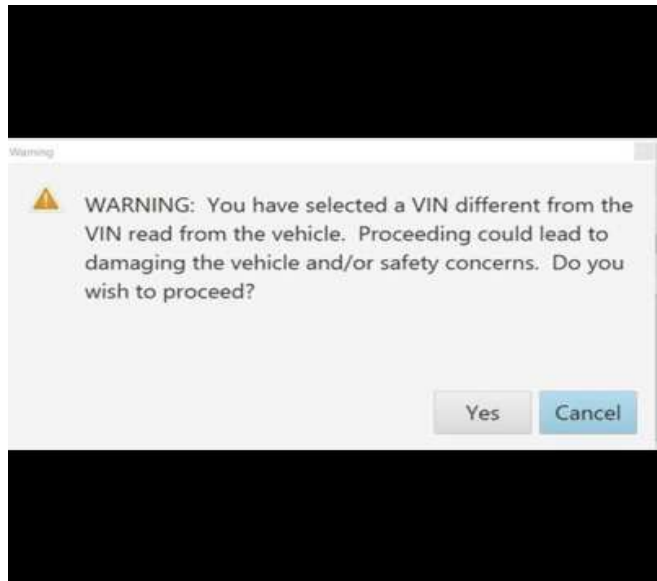
5877000

Important: If the vehicle VIN DOES NOT match, the message below will be shown

Important: Techline Connect screens shown above.
