# Service Bulletin

Bulletin No.: 22-NA-186

**Subject:** IPC Displays Service Camera System Message or Various IPC Drive Modes Cannot Be Selected and/or DTC U0155 Set

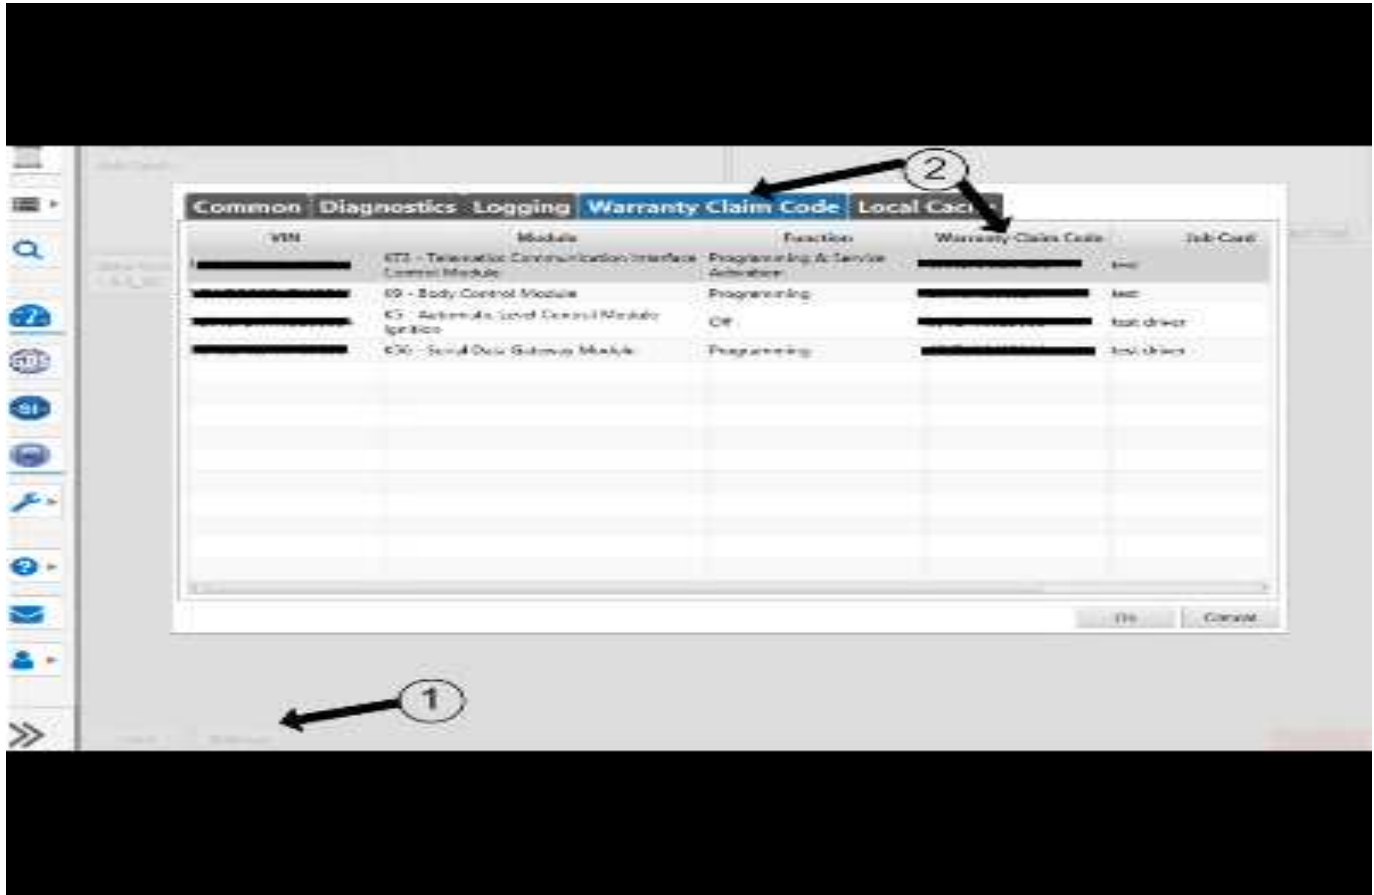
6125774

Warranty Claim Code Information Retrieval

If the Warranty Claim Code was not recorded on the Job Card, the code can be retrieved in the SPS2 system as follows:

The VIN, Warranty Claim Code and Date/Time will be listed on a roster of recent programming events. If the code is retrievable, dealers should resubmit the transaction making sure to include the code in the SPS Warranty Claim Code field.
