# Technical Service Bulletin

## 01 MIL on, DTC for "System rich" (P1137 and/or P1139)

01 12 63 2031458/2 December 17, 2012. Supersedes Technical Service Bulletin Group 01 number 12-58 dated November 5, 2012 for reasons listed below.

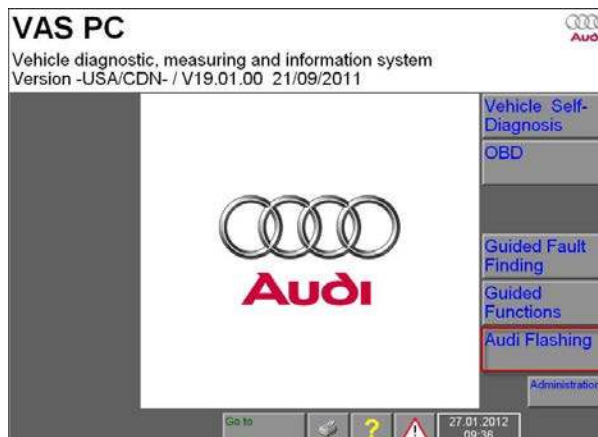
**Figure 2.** Audi Flashing.

- Turn off any appliances with high electromagnetic radiation (such as mobile phones).
  - If communication with a module cannot be properly established, appropriate repairs must be made before attempting SVM. If the tester cannot communicate with a module, the tester cannot flash software onto the module.
5. Enter the SVM code into the User Test Plan by selecting the **Audi Flashing** option at the main tester screen, unless otherwise directed by the TSB or TAC Helpline.
