# Service Bulletin

Bulletin No.: 24-NA-278

**Subject: BCM Software Update Needed – DTC B1AAE.13: Passive Entry Closure 2 Antenna Circuit High - Circuit Open**

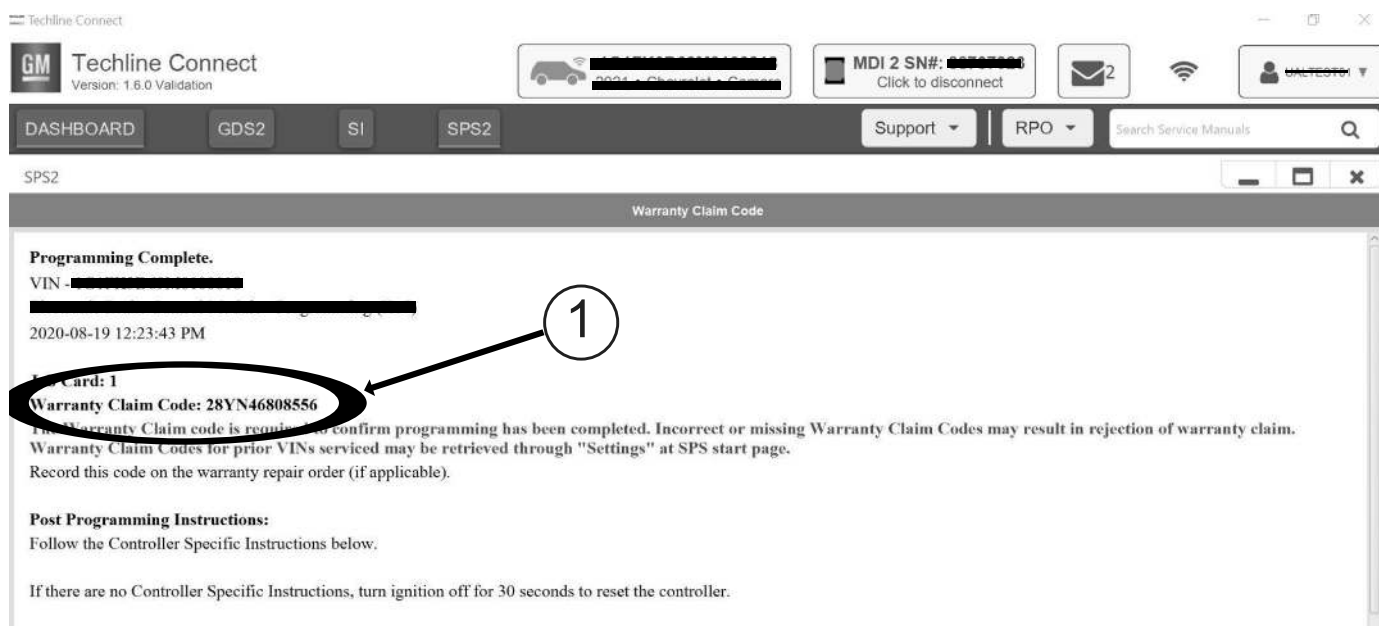
5644478

1. Reprogram the Body Control Module. Refer to *K9 Body Control Module: Programming and Setup*.

**Note:** The screenshot above is an example of module programming and may not be indicative of the specific module that is being programmed. Module selection and VIN information have been blacked out.
