## Technical Service Bulletin (TSB)

### DXR USB Update to v1.4.160 For MIM Radio

| REFERENCE: | TSB: 08-191-25 REV. A<br>GROUP: 08 - Electrical | Date: | August 27, 2025 | REVISION: | 08-191-25 |
| VEHICLES AFFECTED: | 2024 (LB) Dodge Charger<br>**This bulletin applies to vehicles equipped with a: <ul style="list-style-type: none"><li>• Drive eXperience Recorder (Sales Code JFC).</li><li>• Drive eXperience Recorder Prep (Sales Code JGB).</li><li>• Uconnect 5 Nav W 12.3" Display (USA) (Sales Code UBX).</li><li>• Uconnect 5 Nav W 12.3" Display (CAN) (Sales Code UEX).**</li></ul> | | | MARKET APPLICABILITY:<br><div><input checked="" type="checkbox"/> NA<input type="checkbox"/> MEA</div> <div><input type="checkbox"/> SA<input type="checkbox"/> IAP</div> <div><input type="checkbox"/> EE<input type="checkbox"/> CH</div><br><b>NOTE:</b> This bulletin applies to the North America market. | |

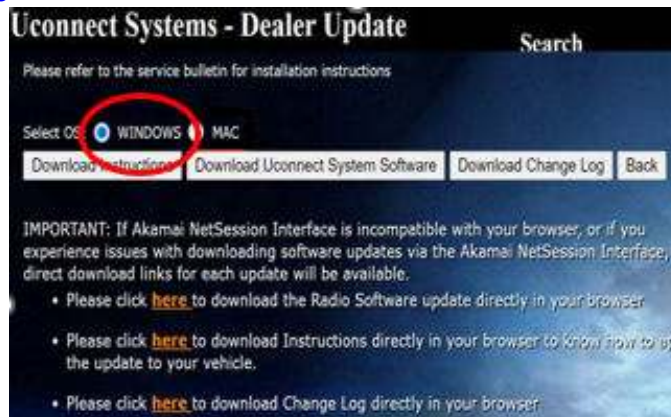
**Fig. 8**

15. Download the software update file to your local PC's desktop. Make sure to select the “WINDOWS” radial button for all downloads [Fig. 8](#).

## WINDOWS Download Steps

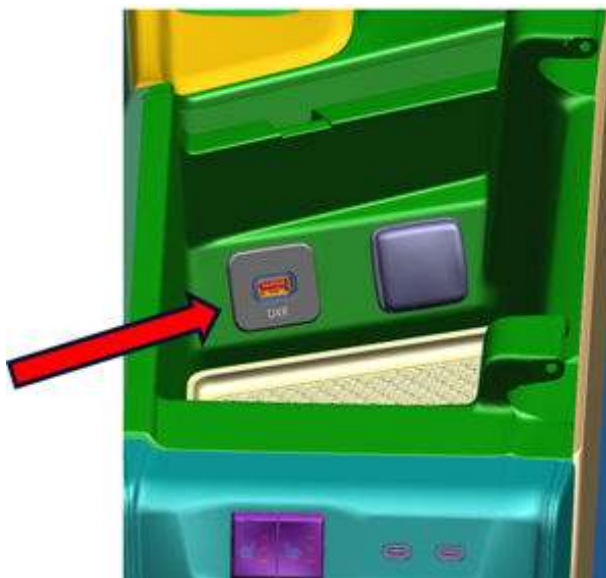
**Fig. 10**  
DXR USB

22. Start the vehicle and insert the USB flash drive into the DXR USB port [Fig. 10](#).
