**Technical Service Bulletin (TSB)**  
**DXR USB Update to v1.4.160 For MIM Radio**

| REFERENCE: | TSB: 08-192-25 REV. A<br>GROUP: 08 - Electrical | Date: | August 28, 2025 | REVISION: | 08-192-25 |
| VEHICLES AFFECTED: | 2025 (LB) Dodge Charger<br>**This bulletin applies to vehicles equipped with a: <ul style="list-style-type: none"><li>• Drive eXperience Recorder (Sales Code JFC).</li><li>• Drive eXperience Recorder Prep (Sales Code JGB).</li><li>• Uconnect 5 Nav W 12.3" Display (USA) (Sales Code UBX).</li><li>• Uconnect 5 Nav W 12.3" Display (CAN) (Sales Code UEX).**</li></ul> | | | MARKET APPLICABILITY:<br><div><input checked="" type="checkbox"/> NA<input type="checkbox"/> MEA</div> <div><input type="checkbox"/> SA<input type="checkbox"/> IAP</div> <div><input type="checkbox"/> EE<input type="checkbox"/> CH</div><br><b>NOTE:</b> This bulletin applies to the North America market. | |

This bulletin involves inspecting and if required, updating the radio software level to 1.4.160.

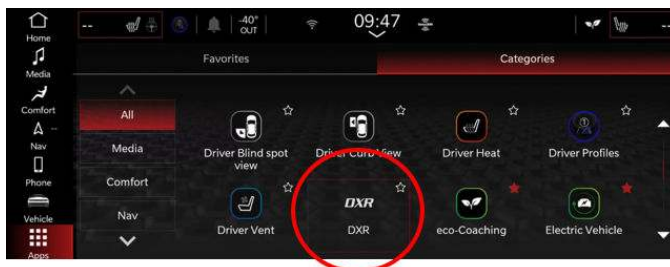
**Fig. 2**  
DXR

- Locate the DXR tile and select it [Fig. 2](#).

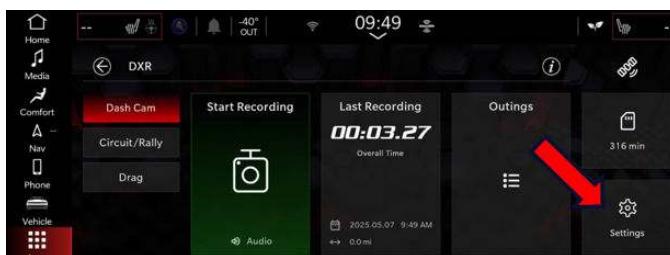
**Fig. 4**  
Settings

- Click the Settings button to open the settings menu [Fig. 4](#).

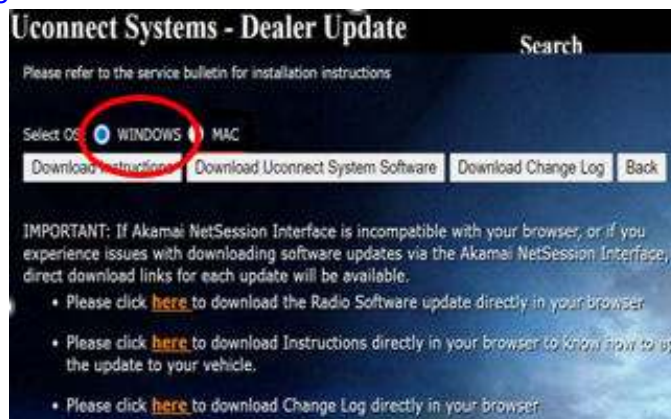
**Fig. 8**

15. Download the software update file to your local PC's desktop. Make sure to select the “WINDOWS” radial button for all downloads [Fig. 8](#).

## WINDOWS Download Steps

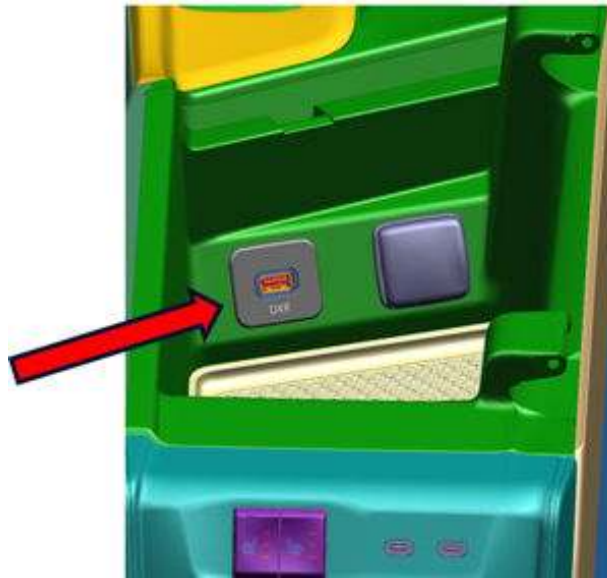
**Fig. 10**  
DXR USB

22. Start the vehicle and insert the USB flash drive into the DXR USB port [Fig. 10](#).

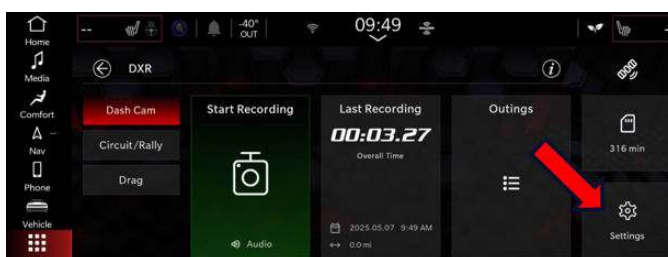
**Fig. 14**  
Settings

27. Click the Settings button to open the settings menu [Fig. 14](#).

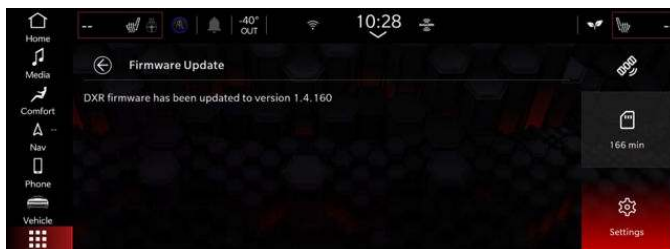
**Fig. 18**

31. This message will be displayed when the update is complete [Fig. 18](#).

Software Updated Screen
